D. 9518

Swindon Type 1 Locomotive

1964 to 2015

D. 9518 Timeline

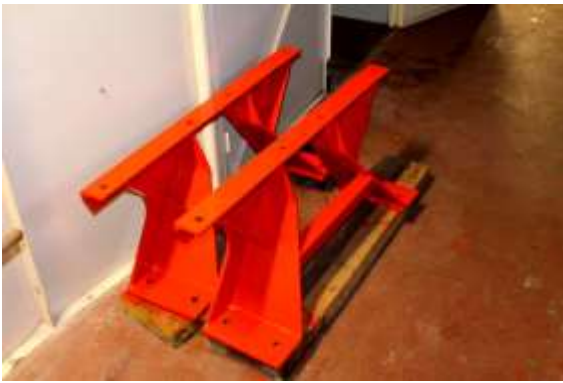
A lot of time has been spent locating parts that had been removed from the loco, there are still outstanding items, but here are the first pieces restored, exhaustor mounting brackets, ex D9500 - 03/11/12 (Simon Purvis)

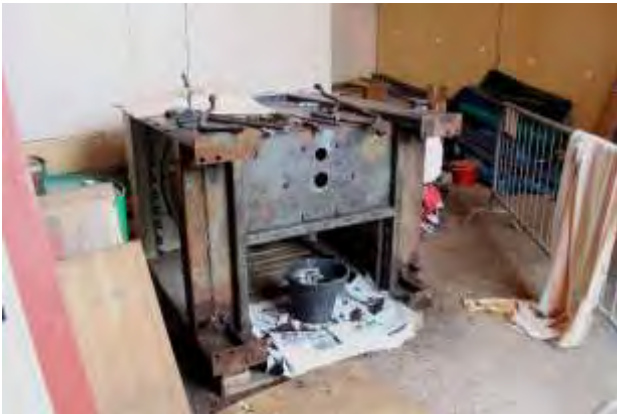
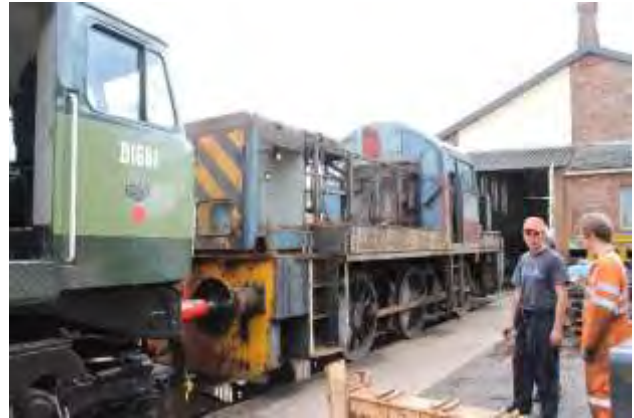
Minus bonnet sections and ready to lift out the cooler group 14/09/13 (Terry Deacon)

Cooler group undergoing restoration 05/04/14

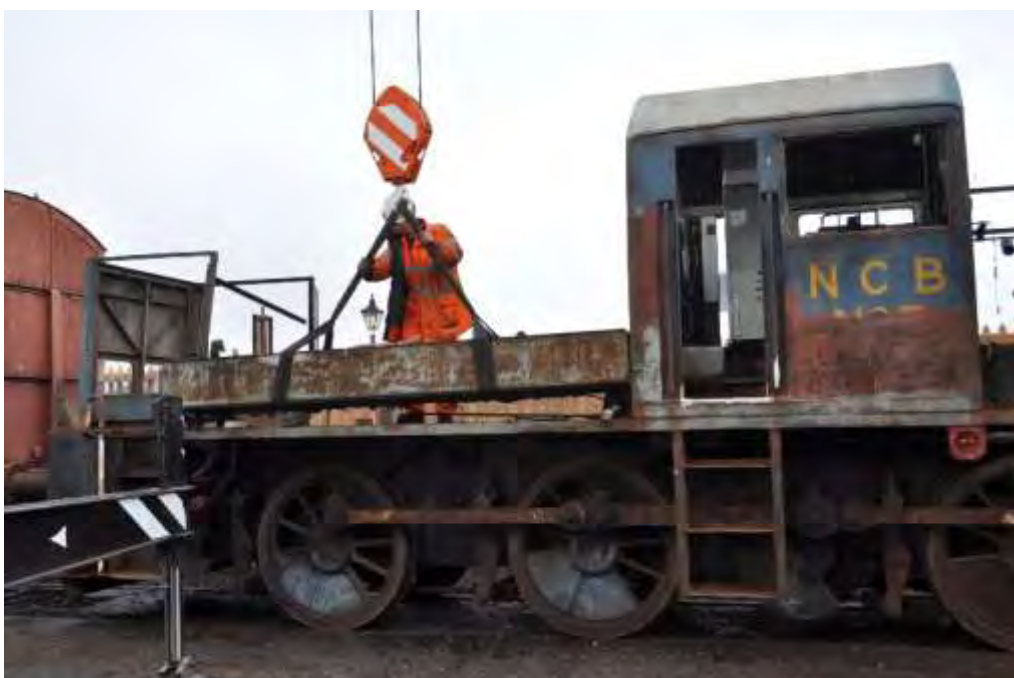
Opportunity was taken to use a road mobile crane 11/12/14 and the two fuel tanks, control cubicle and brake frame were lifted out of the loco (G.Perry)

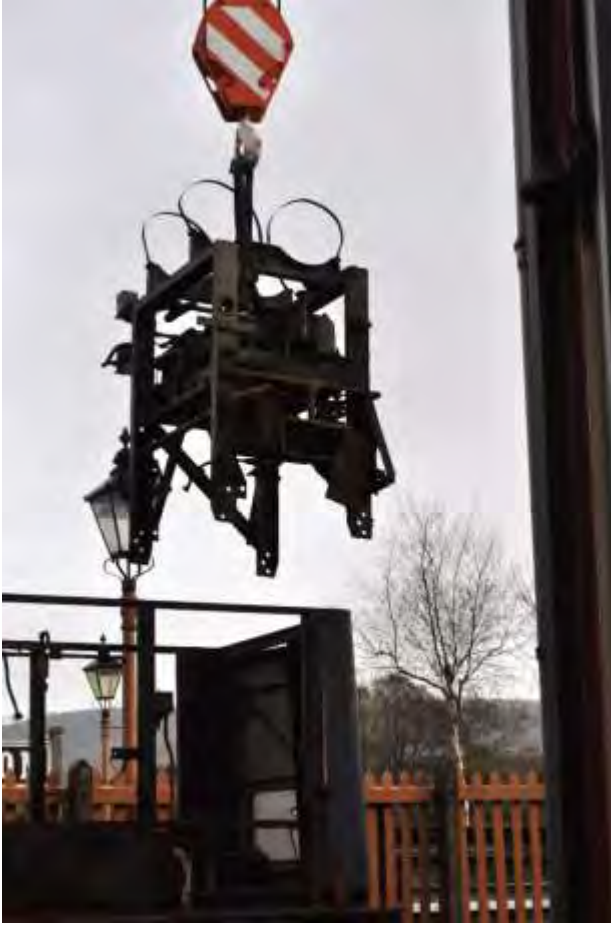
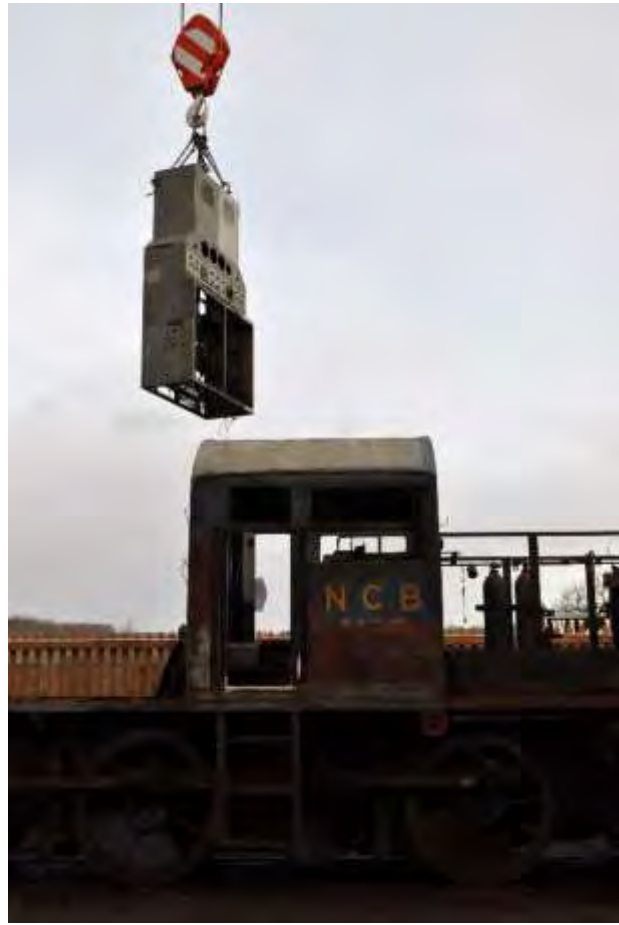
Brake Frame lift and Control cubicle above cab (G.Perry)

With these components out of the way, other components could also be released in preparation for removal.

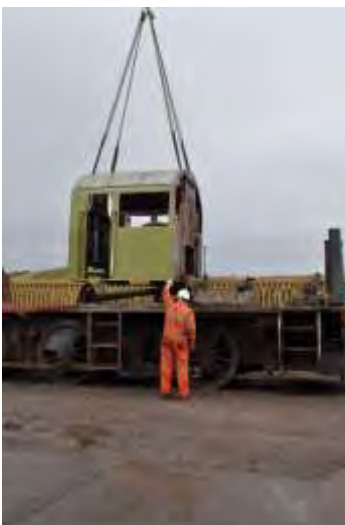
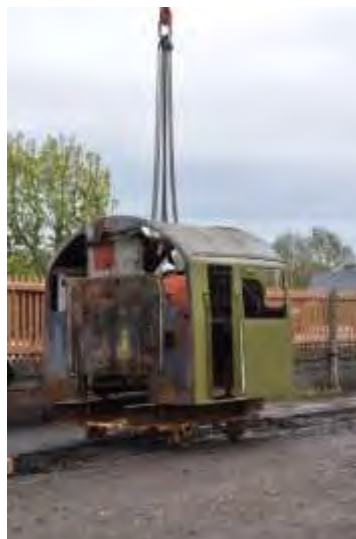
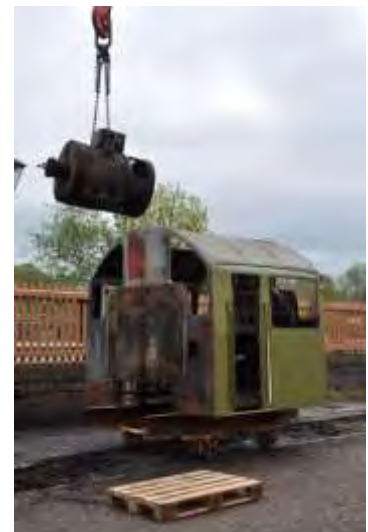
A mobile crane was used for the second time on the 08/05/15 Firstly the cab was removed. Which was placed on a trolley so it can be moved around the site. (G.Perry)

Followed by the generator. This will need sending away for specialist repair before refitting. (G.Perry)

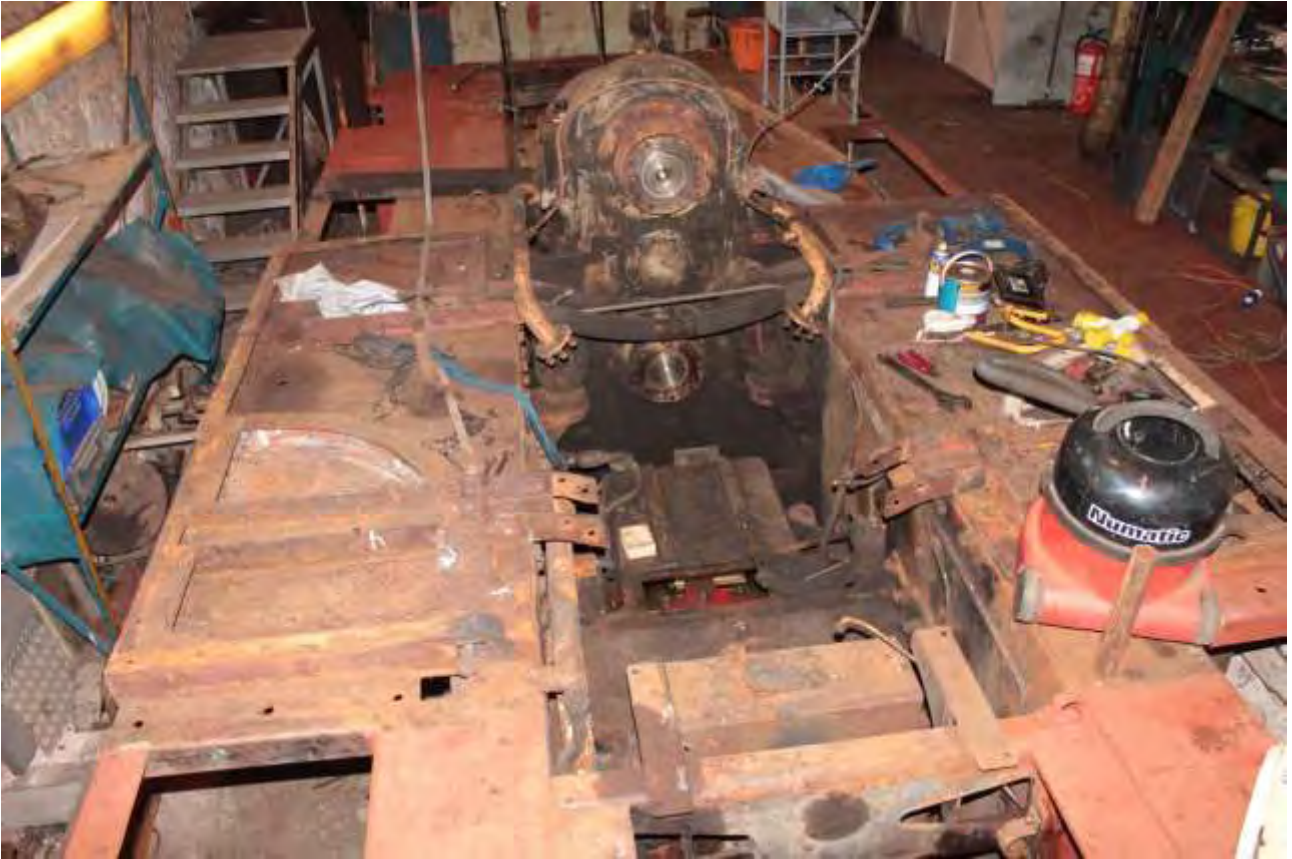
The rear 'nose end' was also taken off at this time

Attention being given to final drive reversing gear 29/08/15 (Terry Deacon)

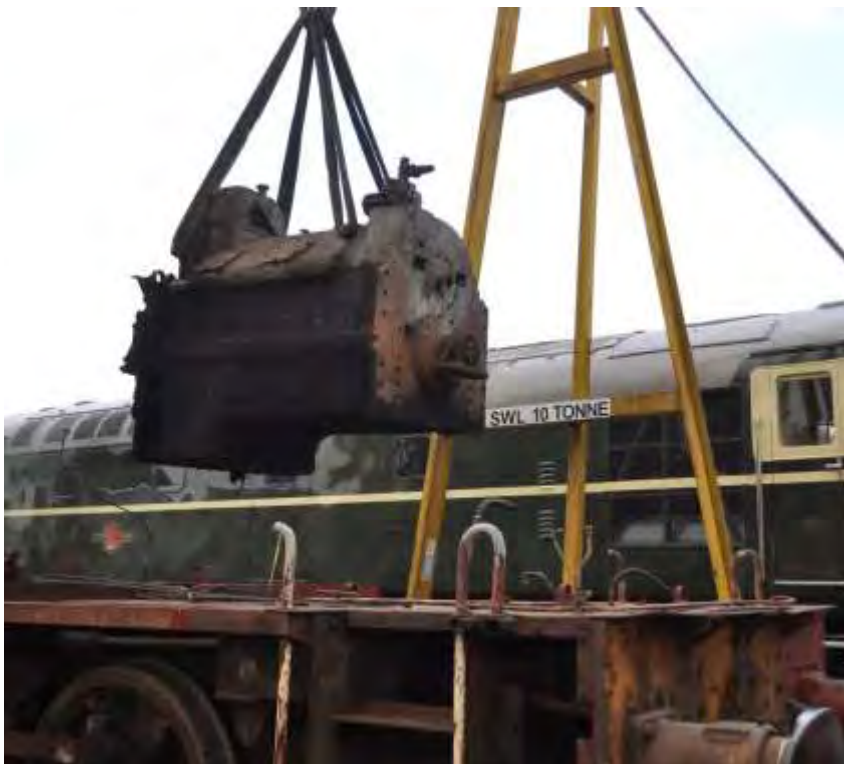
Voith Transmission lifted out 18/10/15 (G. Perry)

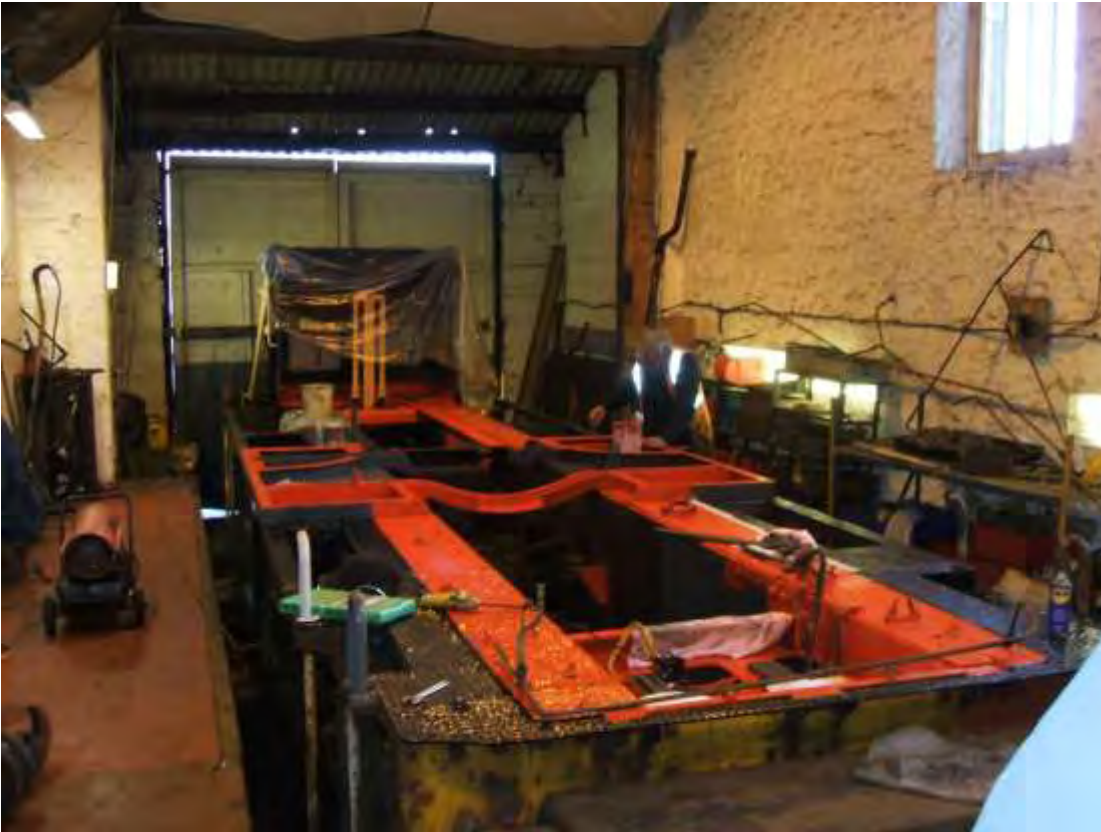
Work continues with cleaning, inspection and painting 'between the frames' View from the rear of the loco looking towards the front. (Simon Purvis)

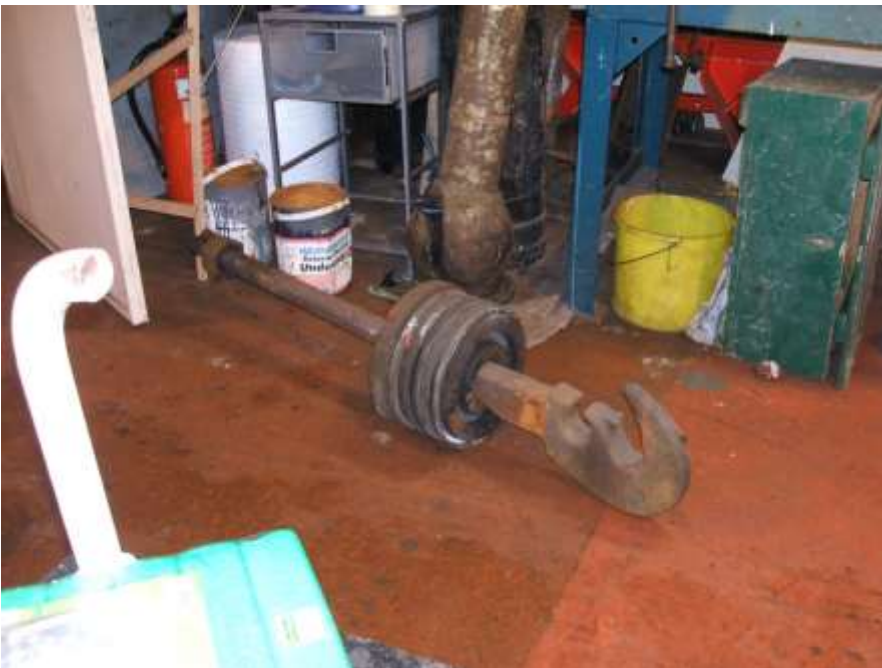
Rear Draw hook removed for inspection of compression rubber rings and wear. (Simon Purvis)
