## D. 9526

### Swindon Type 1 Locomotive

1964 to 2015

## D.9526 Timeline

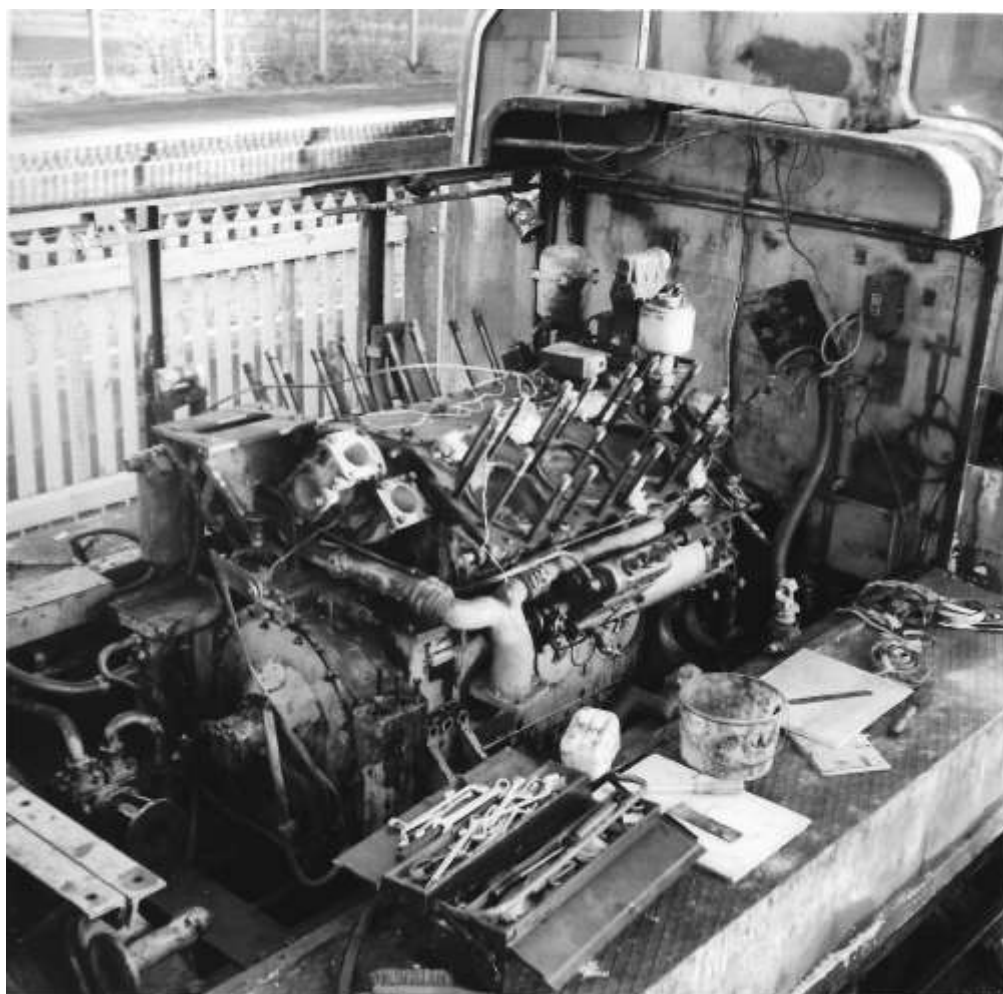
'Fresh air' engineering being carried out - Engine work continues B1 piston (nearest the camera) was eventually changed

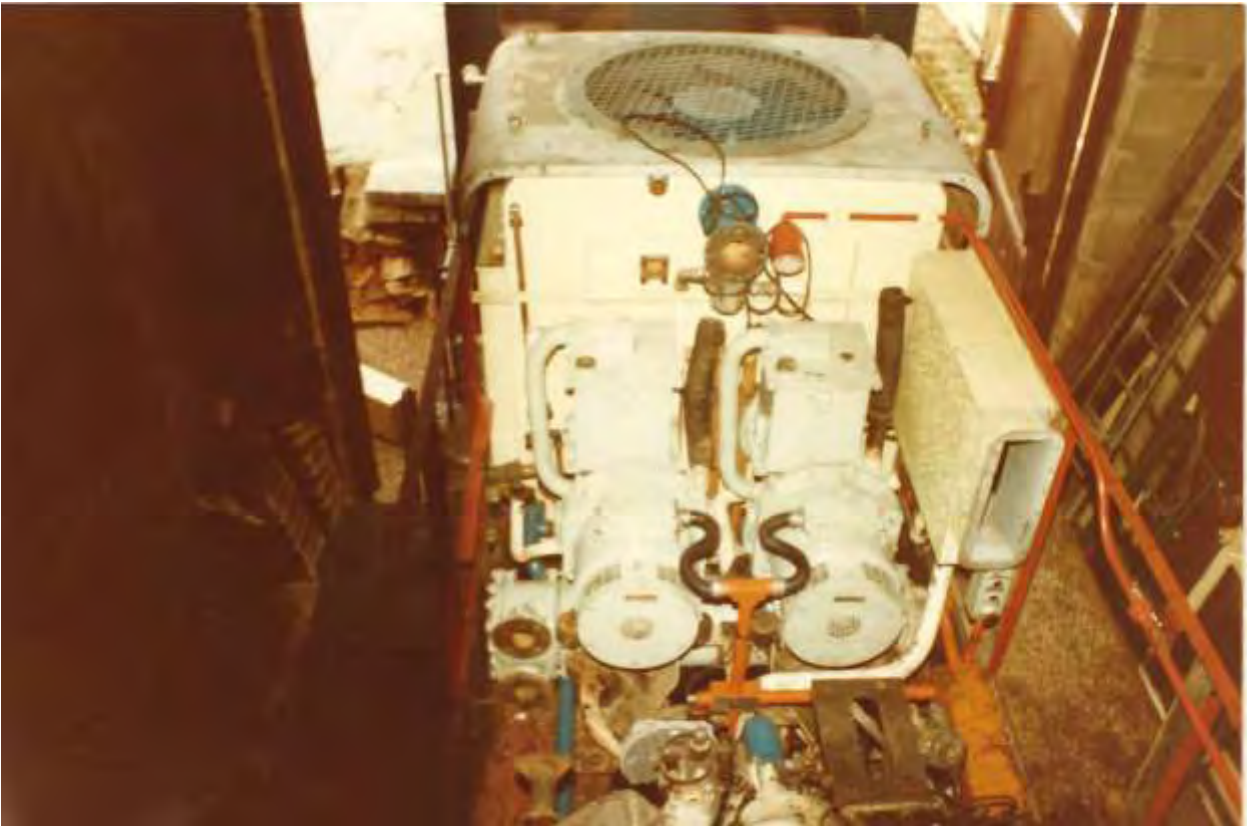
The restored cooler group, exhausters being 'plumbed' in, and under these, the repaired transmission heat exchanger are seen in this Photograph circa 1983. Photo (*PJ Hembry*)

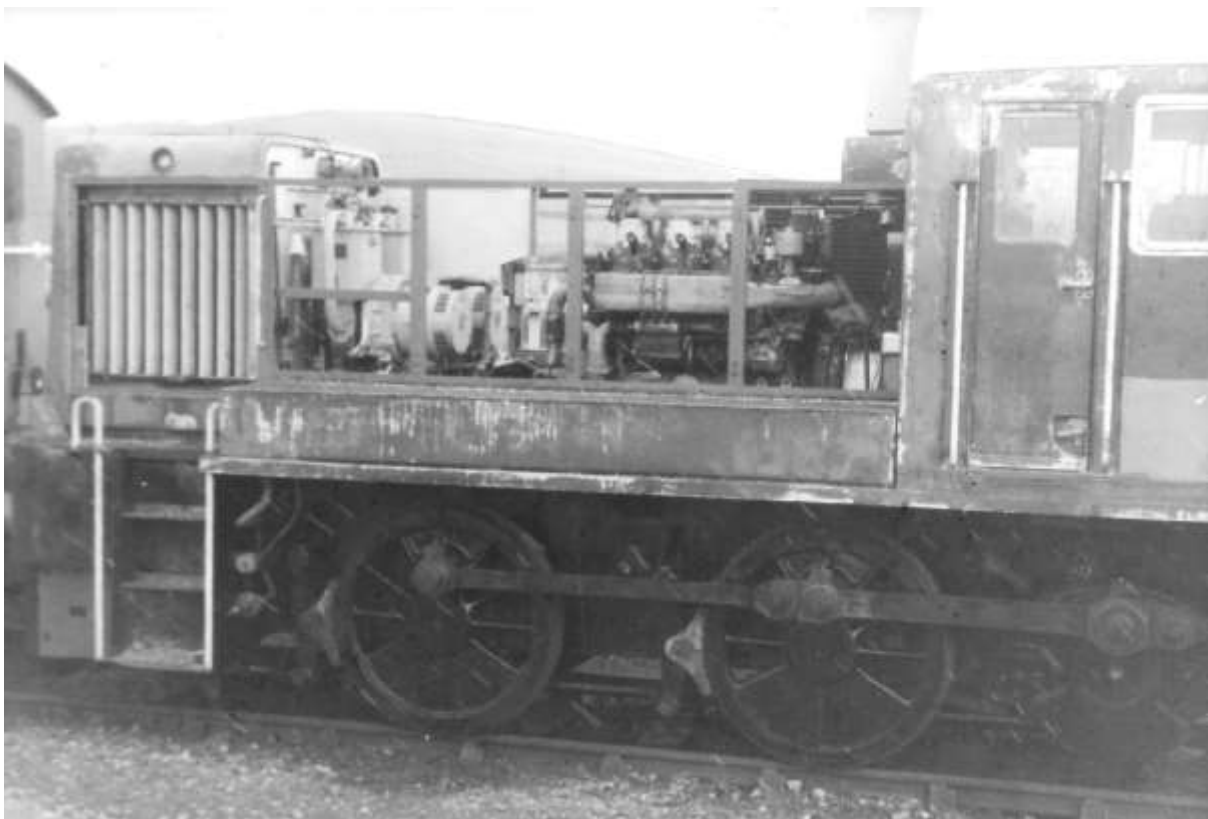
The engine has been rebuilt but is awaiting a turbocharger circa 1983

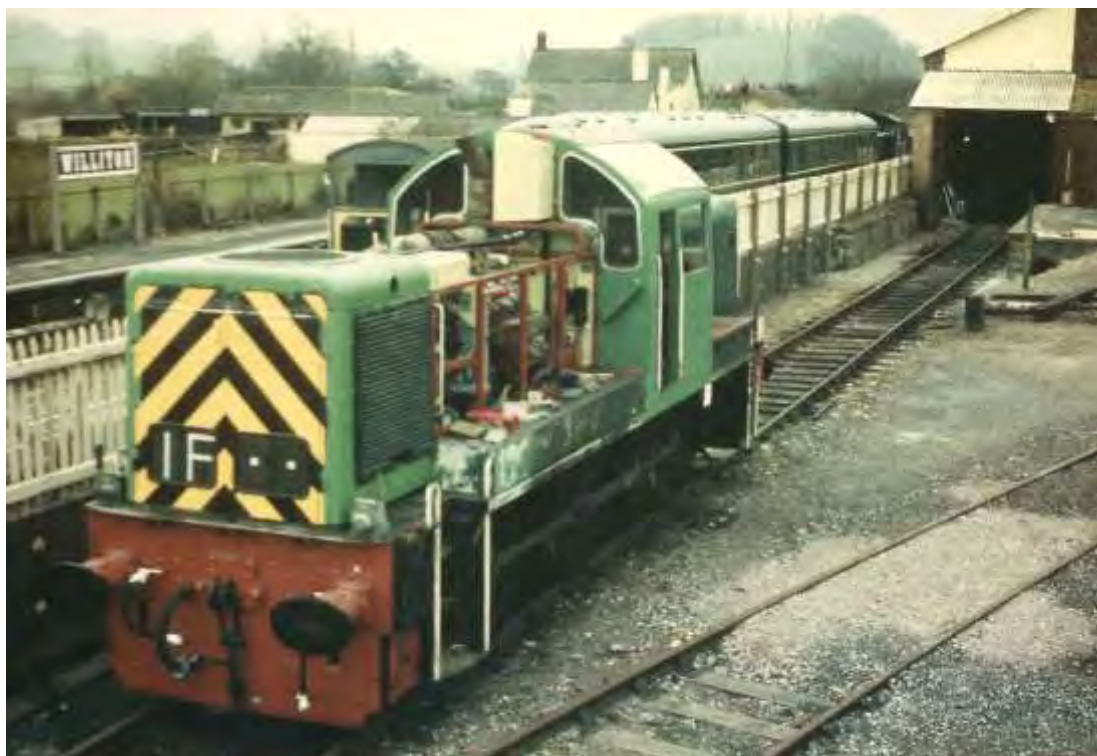
D9526 is posed outside Williton shed, the original nose end doors were in very poor condition and these were 'exchanged' with a scrap class 14 in Corby. Circa 1983

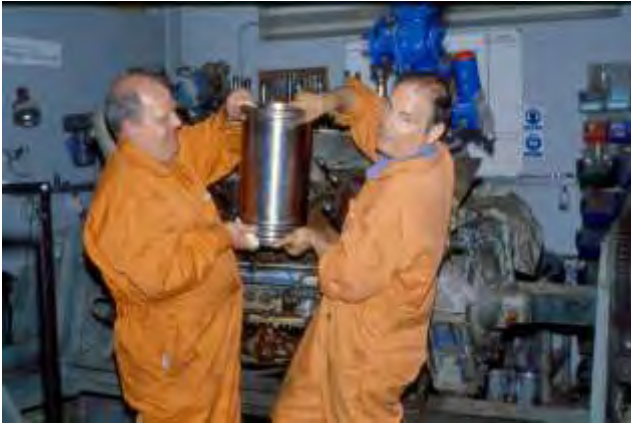
Fitting of cylinder liners *Photo (I Robbins)*

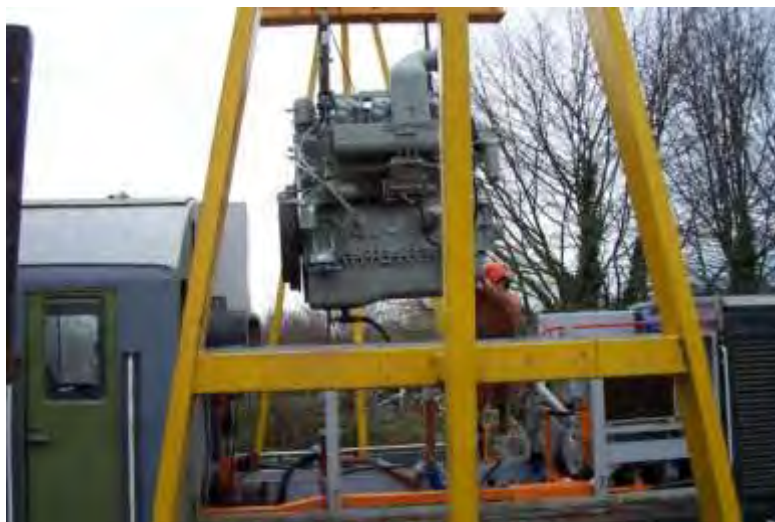
Fitting of overhauled engine *Photo (I Robbins)*

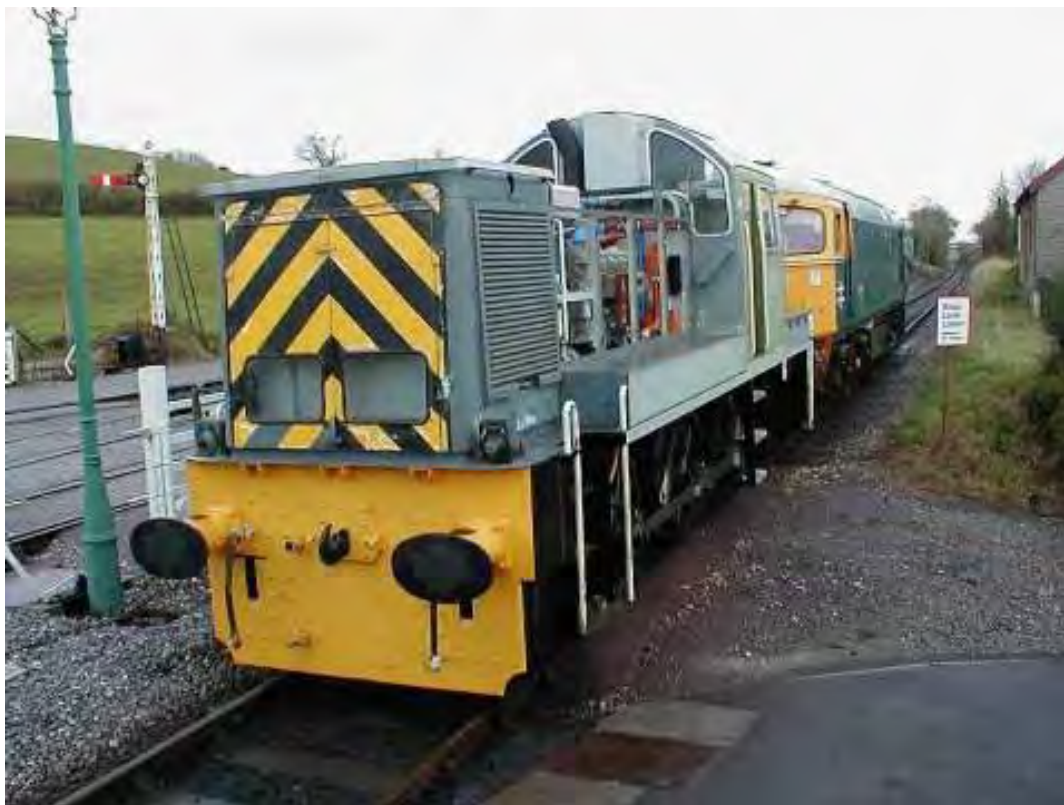
30/11/02 Test run at Washford. The loco was run minus the engine cover so that adjustments and checks could be carried out without difficulty *Photo (I Robbins)*

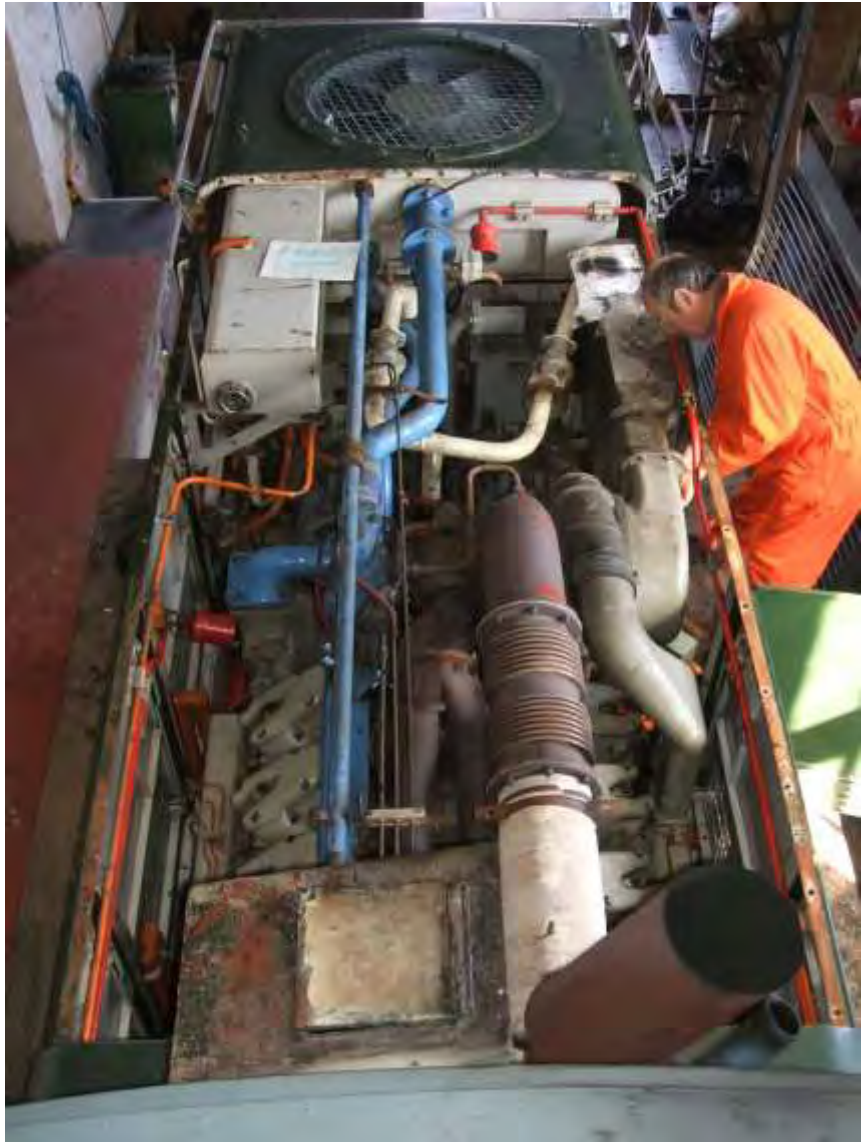
View of engine compartment with bonnet removed *Photo (S.Purvis)*

21/04/12 1000hr exam and service. Included

- 1) rewire from control cubicle to brake frame.
- 2) major engine service, and oil change.
- 3) Voith and final drive oil change.
- 4) tidying up of outstanding faults.
- 5) fit and test electric engine 'pre' heater
- 6) repaint.

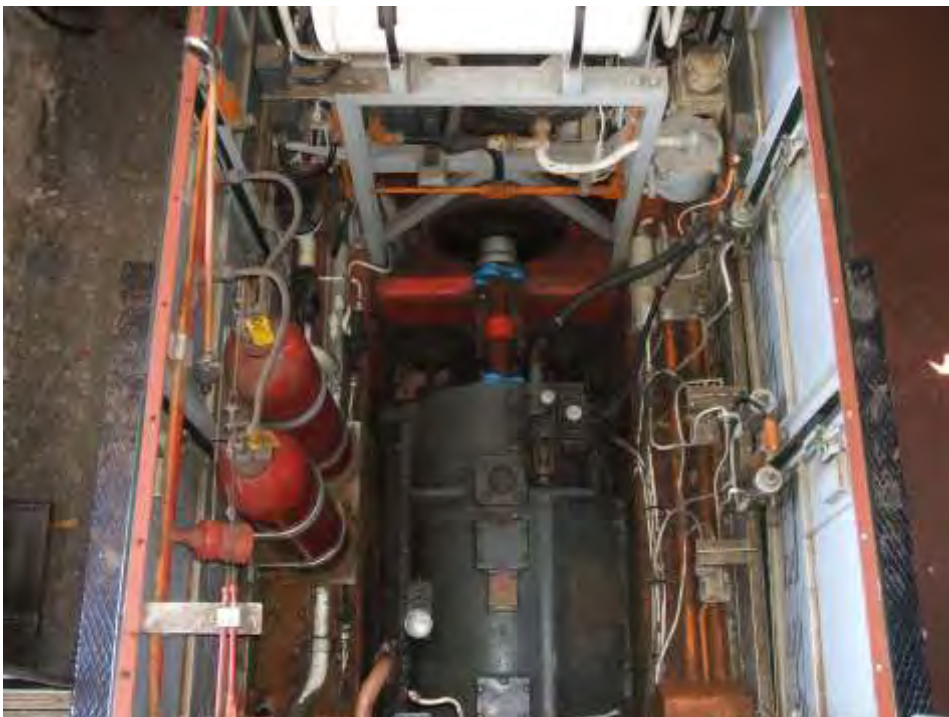
View of transmission compartment with bonnet removed  
*Photo (S.Purvis)*

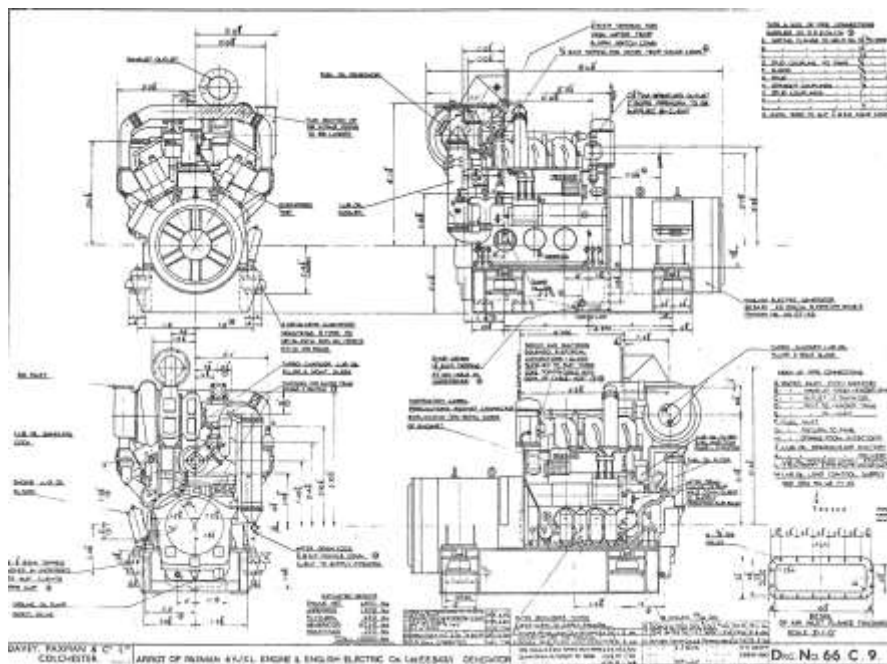
Drawing showing arrangement of a 6YJ for a Class 74 locomotive.

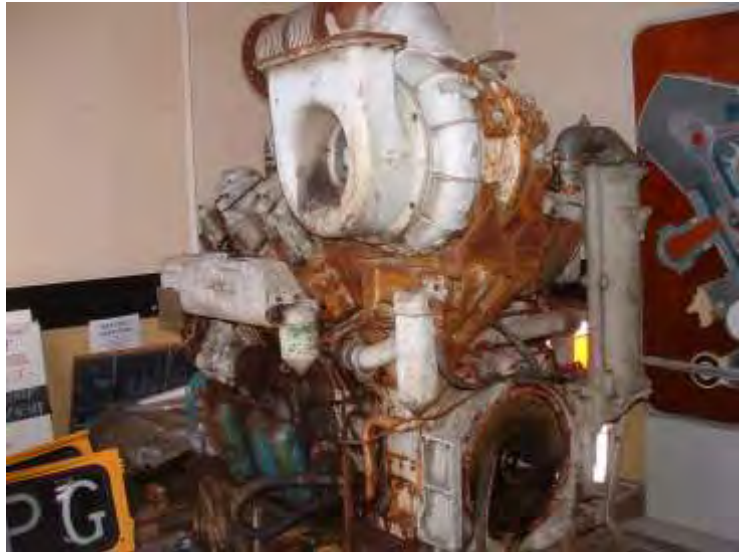
21/11/11 Engine as delivered at Williton

As can be seen, a total engine strip is required as well as sourcing different parts. This engine requires a different flywheel, (as was fitted with a generator) and a crankshaft extension (to drive a Plessey pump for the cooling fan). The turbocharger also requires the ports realigning.

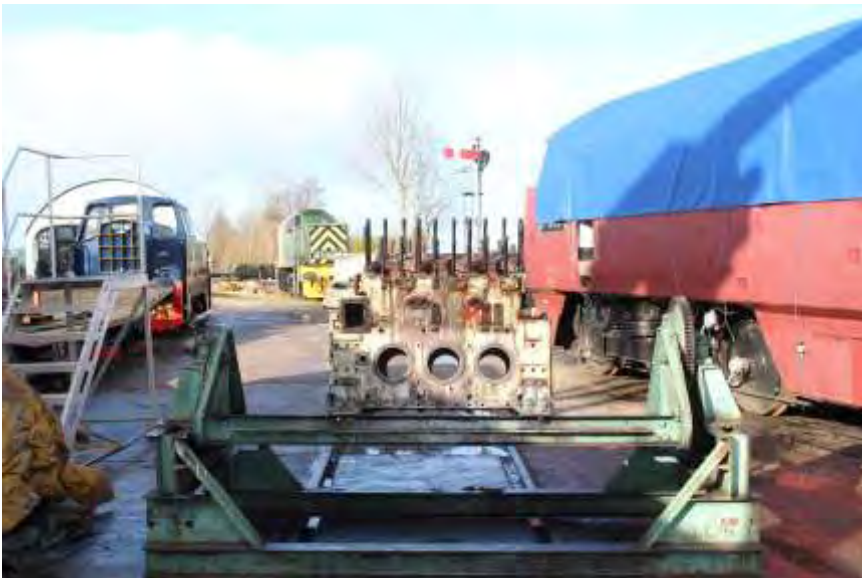
15/02/14 Work started in 2013 to strip this engine to a 'bare' block and this is seen being steam cleaned Photo (*T Deacon*)

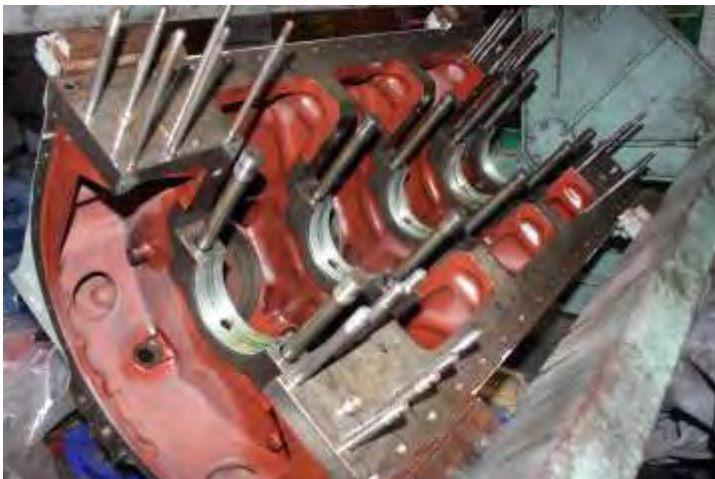
13/02/15 New main bearings fitted  
Note engine in 'turnover' stand Photo (*T Deacon*)

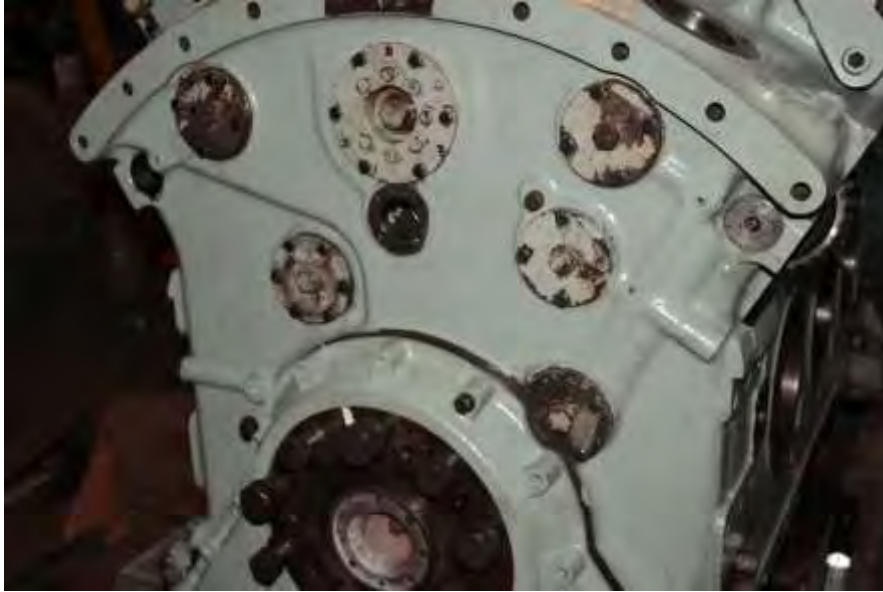
01/08/15 Crankshaft, timing gears and camshaft refitted Photo (*T Deacon*)
