RAILBUS W79978 RESTORATION UPDATE August 2022

Restoration progress

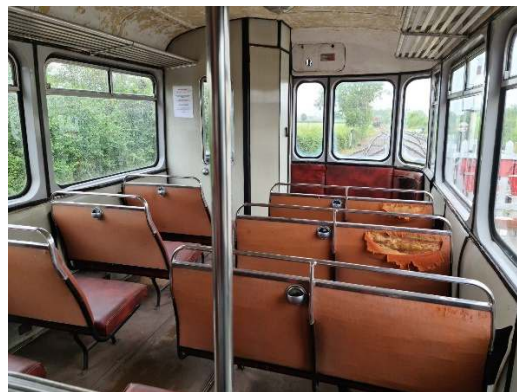
Unfortunately, due to problems with the vehicle's compressed air system, it was not possible for the railbus to be operational, however visitors were able to go inside the railbus and to see at first hand the extent of work required.

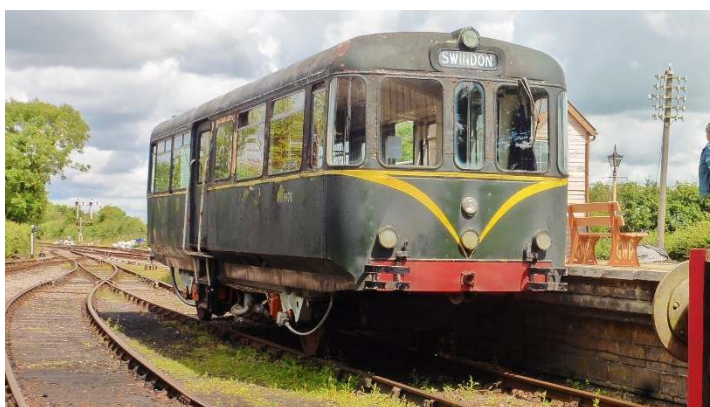
Replacement destination blinds with appropriate destinations have been fitted, the originals were removed many years ago.

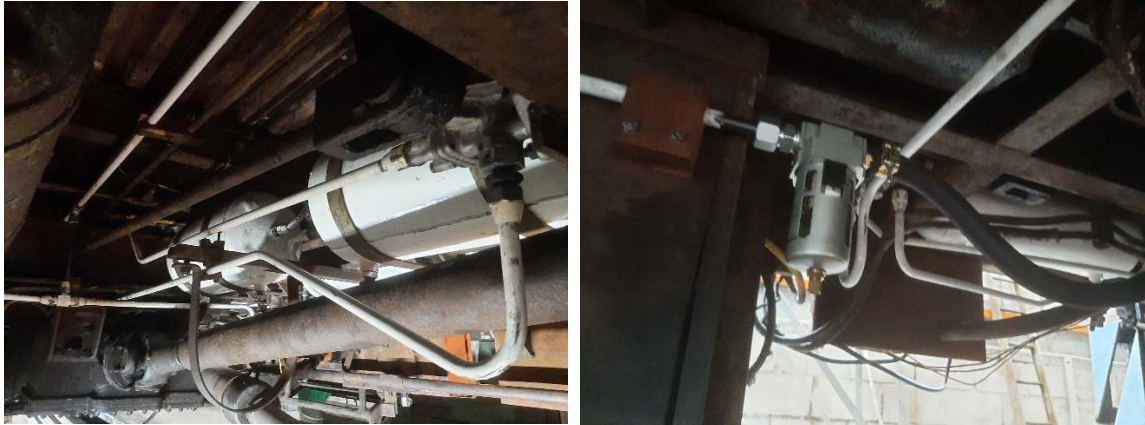
Replacement pipework and additional filters on the air system below the floor of the railbus.

Over the last two months, work has concentrated on rectifying the problems with the air system which prevented the railbus from being operational at the diesel gala.

More than twenty metres of corroded steel pipe have been replaced, control valves overhauled, and additional filters installed to prevent moisture and dirt contaminating the system.

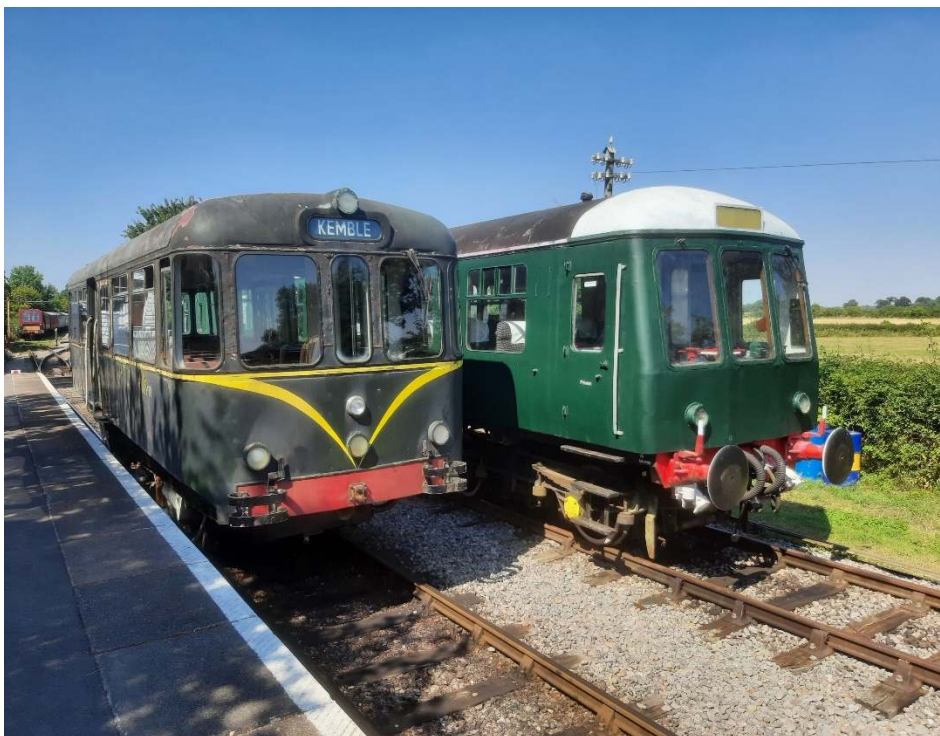
W79978 at Blunston Following several days of work on the air system, the railbus successfully completed two trouble-free round trips between Hayes Knoll and Blunston on Friday 12th August.

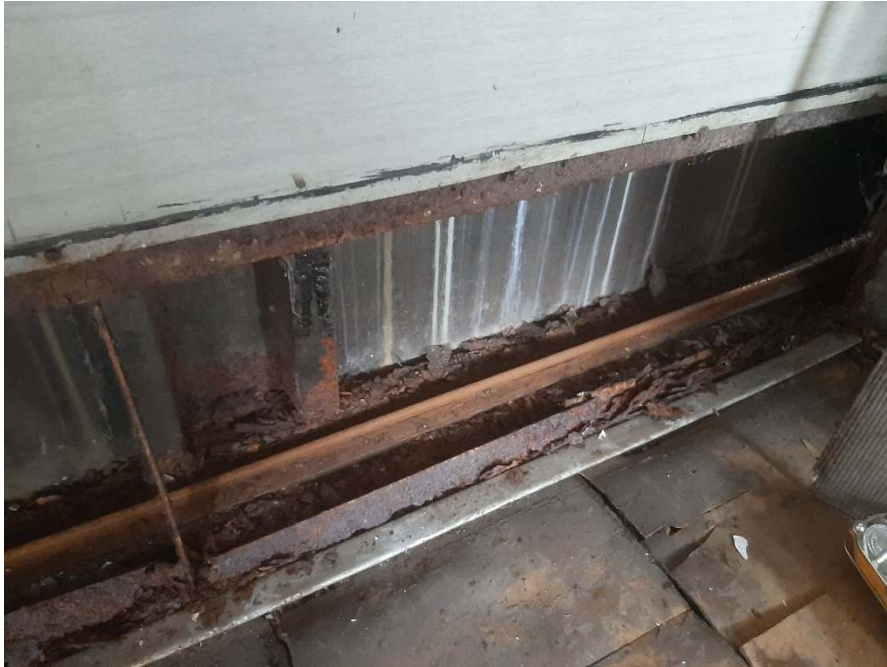
With the interior trim panel removed, the lower runner for the sliding door is visible along with a significant amount of corrosion. The loose debris has been removed and the door runners serviced to allow the doors to function correctly.

In the last couple of weeks, the mechanism for the power operated sliding passenger doors has been repaired and tested, the cab doors at No.2 end have been repaired and the fuel tank filler modified to its original position.

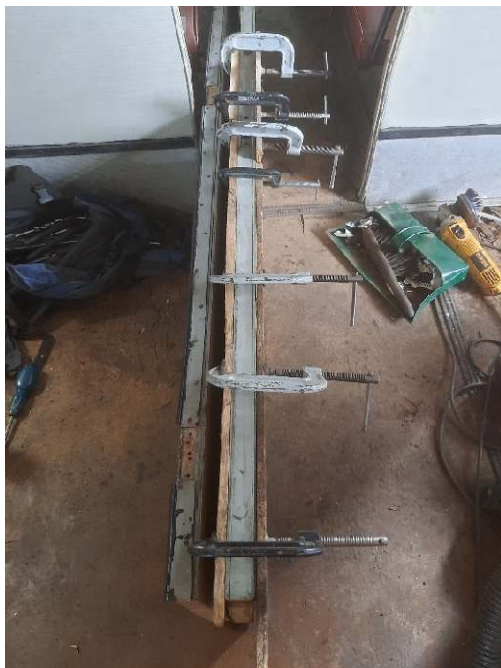
The cab interior door had suffered water damage and the plywood facing panel was detached from the frame. To enable repairs to be carried out the door has been removed. It is seen here with clamps holding the panel in place while the glue sets.

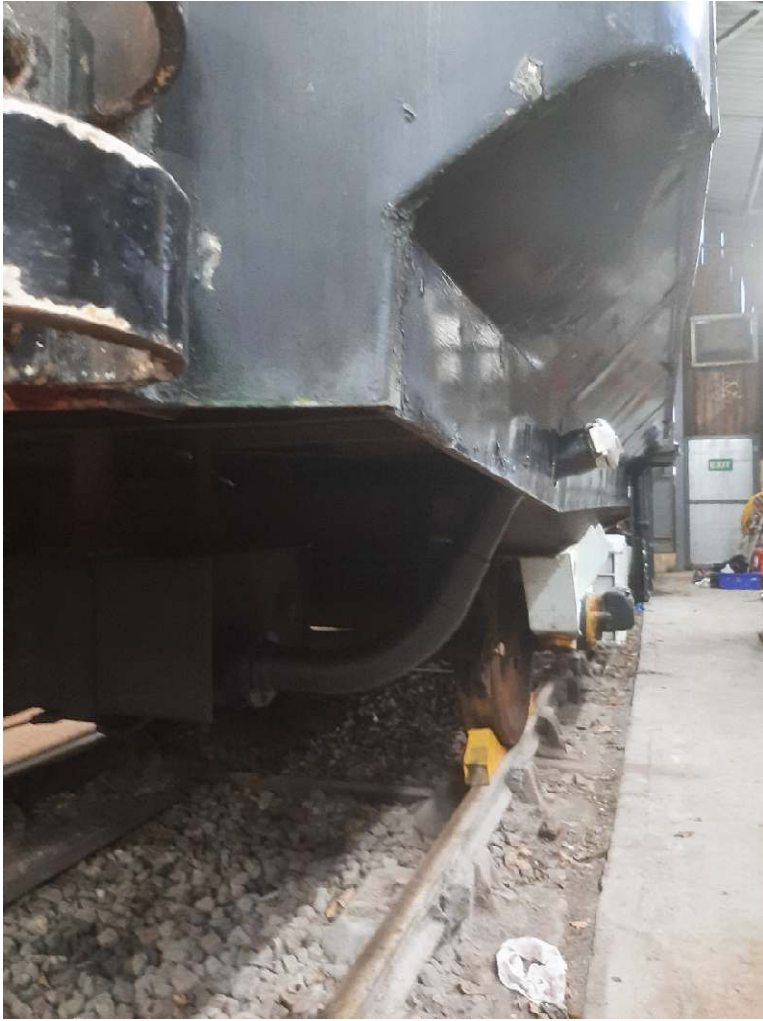
The fuel tank has been replaced at some point in the past with a non-original design, probably a DMU heater fuel tank. This resulted in the filler cap being behind the valence panel, making refueling difficult. The filler has been modified to be in its original position.
