AC Railbus W79978 – restoration update September 2022

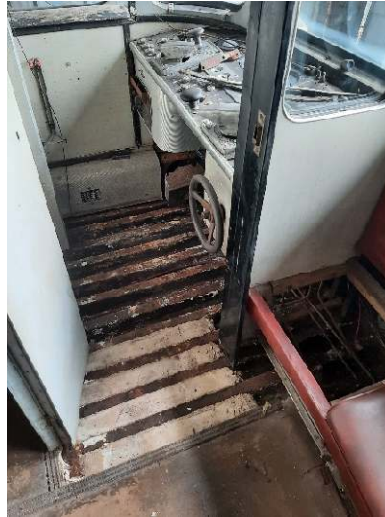
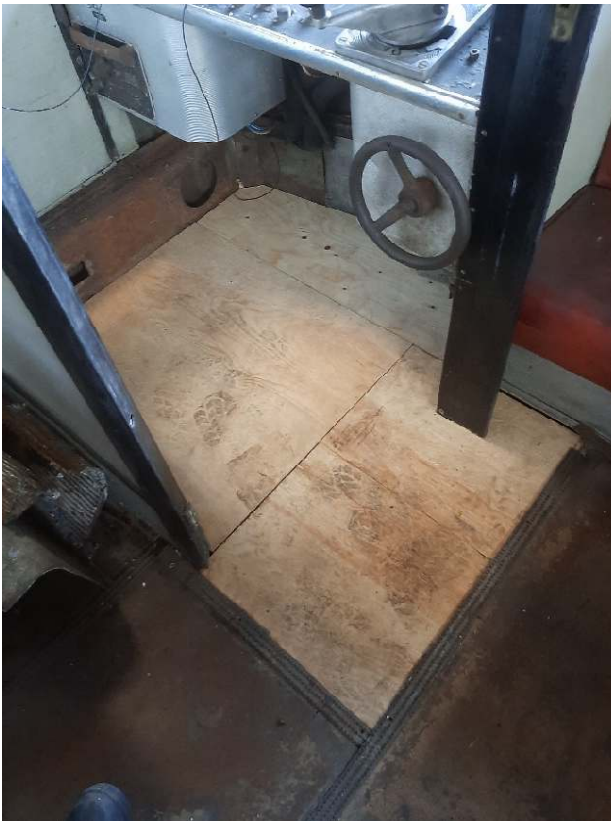
The driving cab floors have suffered severely from water damage. When the remains of the Lino and wood in No2 cab were removed it was found that a section of the floor had been repaired in the past with concrete!

Under the wooden floor is a corrugated steel panel which is in reasonable condition. Replacement plywood has now been cut to shape and fitted; the next step is to install new lino floor covering. While the cab seat is removed it is being retrimmed by Stan Scott. The cab floor at No1 end is also rotten and will require the same treatment.

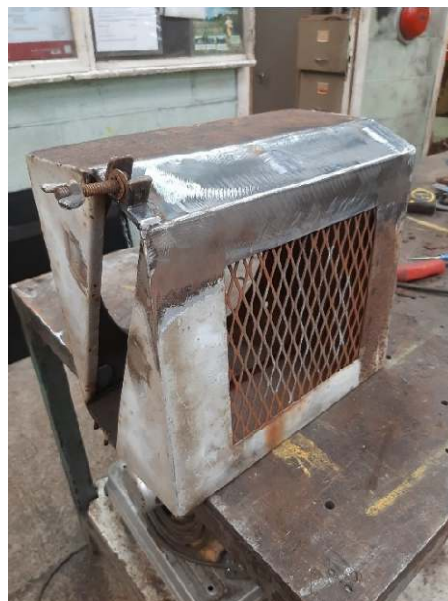
The heater air intake and filter housing were badly corroded. New steel has been welded in place by Martin Luffman

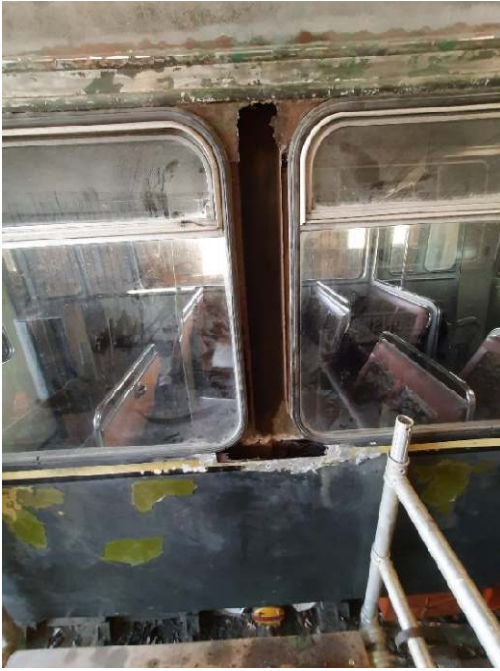
Repairs to the bodysides have begun with corroded sections of outer skin being replaced at No.2 end. The framing behind is severely corroded and will be replaced later. This will involve removal of the windows, luggage racks, interior panels, and seats.
