AC Railbus W79978 – restoration update August 2023

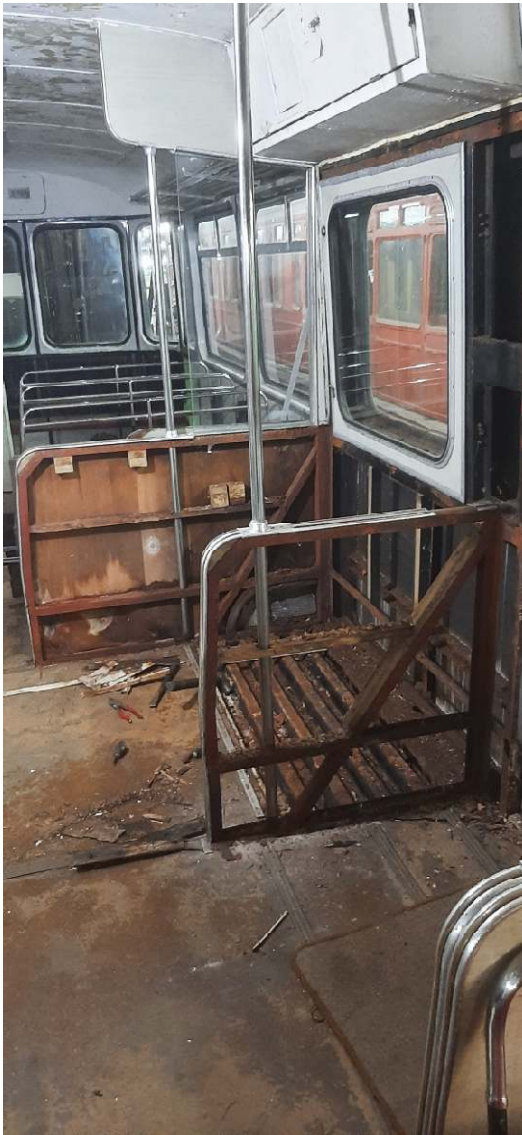
Interior partition panels and floor removal

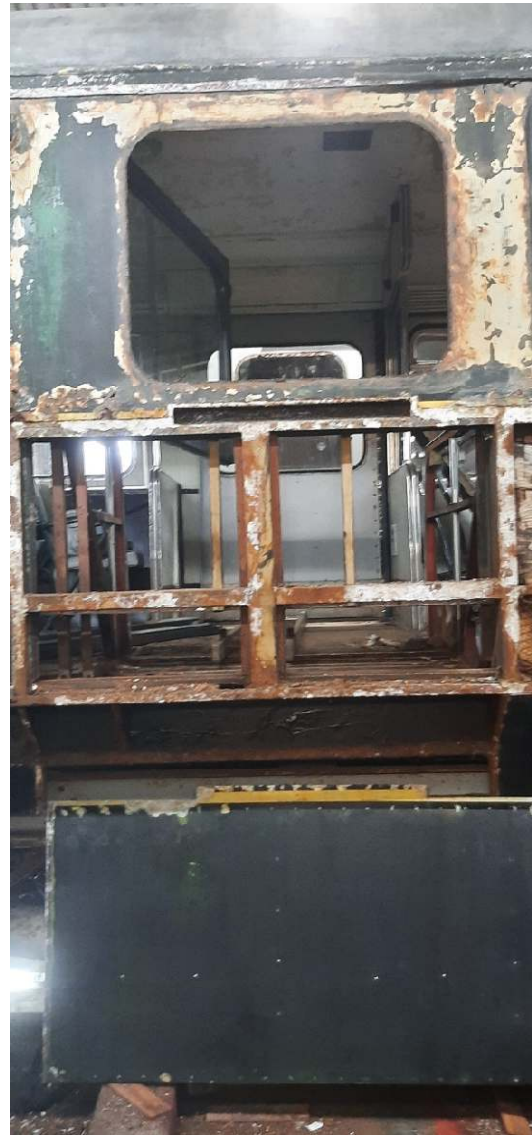
Lower exterior panel and window removed

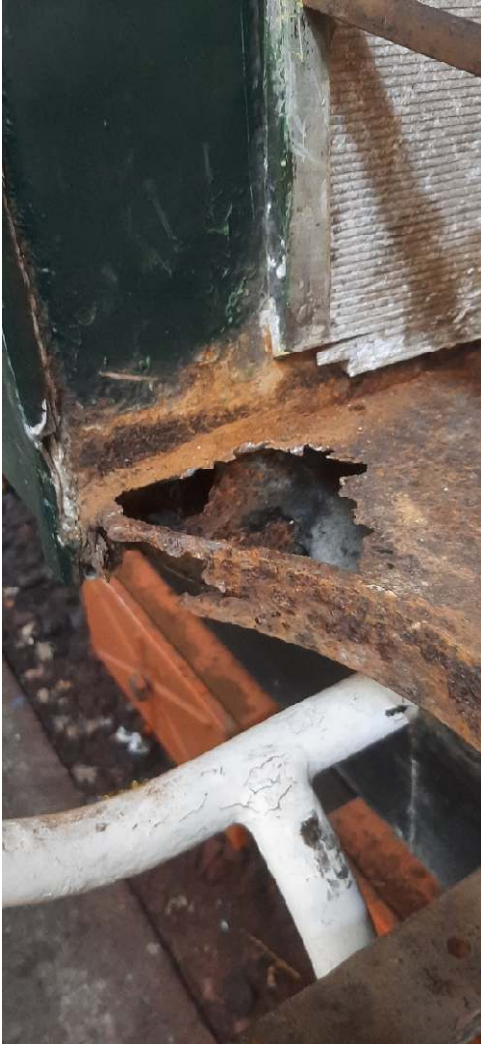
Doorstep frame before repair.

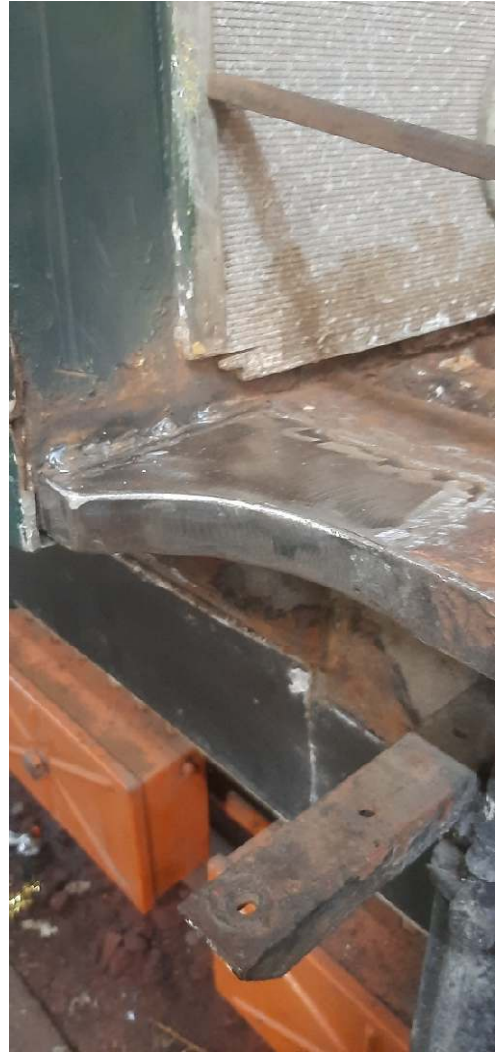
And after.

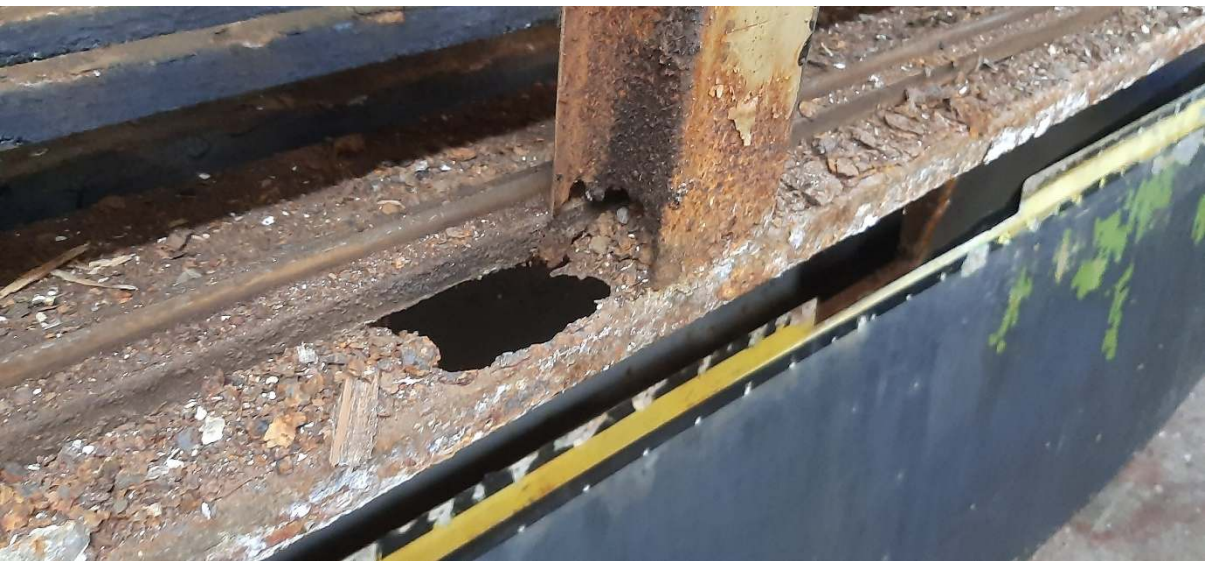
Door runner support plate before.

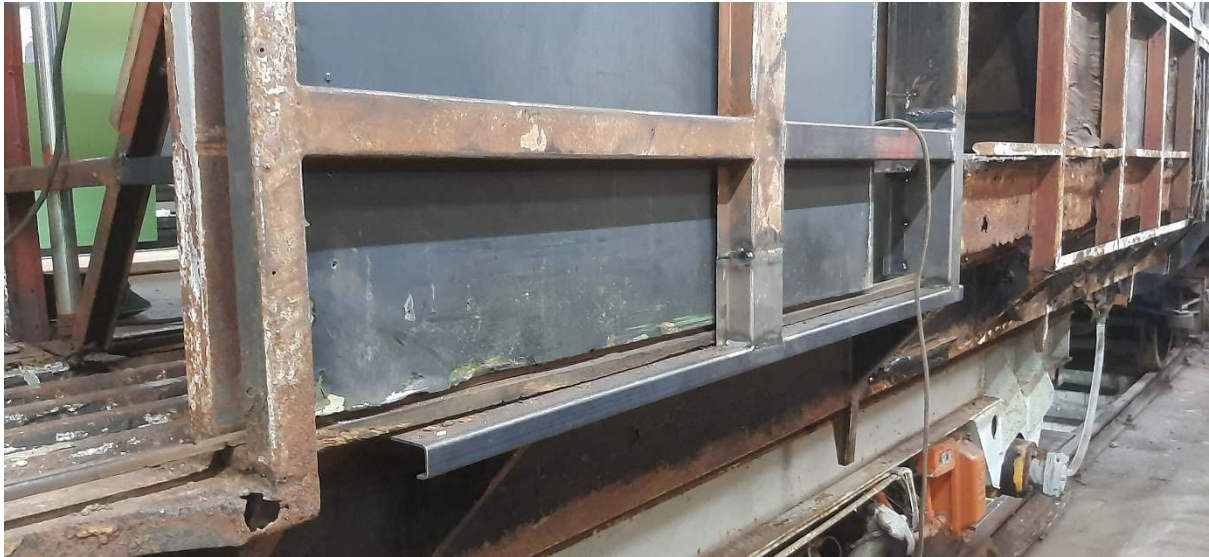
Replacement section welded in place. Also visible are repair sections on two of the bodyside vertical pillars and a horizontal brace which has been replaced.

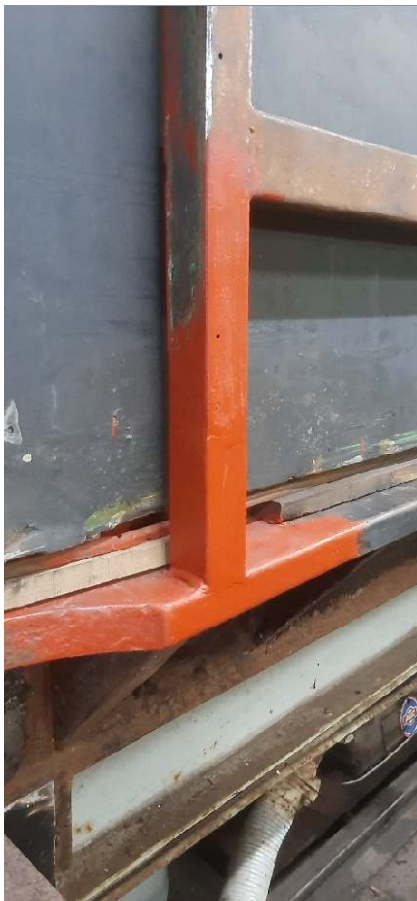
Final section of door runner support plate fitted, also repaired section of outer door post and doorstep.

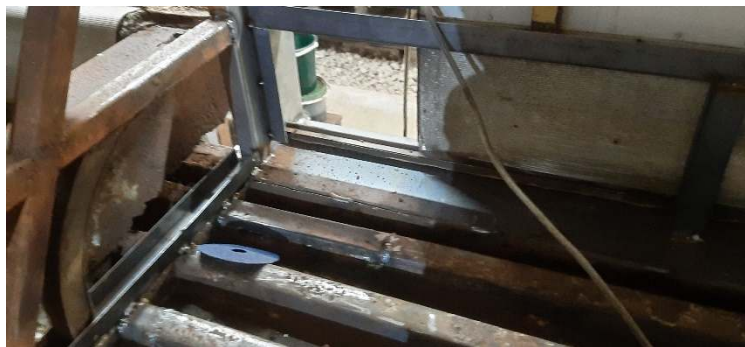
And from the inside. Also visible are a replacement channel section for the partition and repairs to corrugated floor panel.

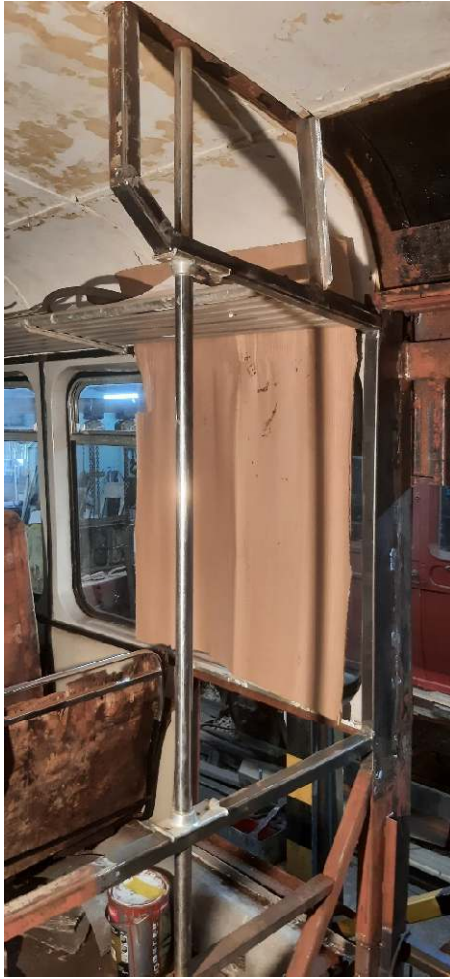
Interior partition frame and bodyside support pillar. Several new sections of steel are visible.

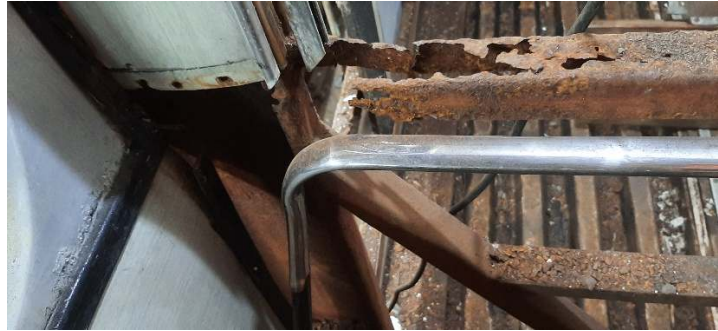
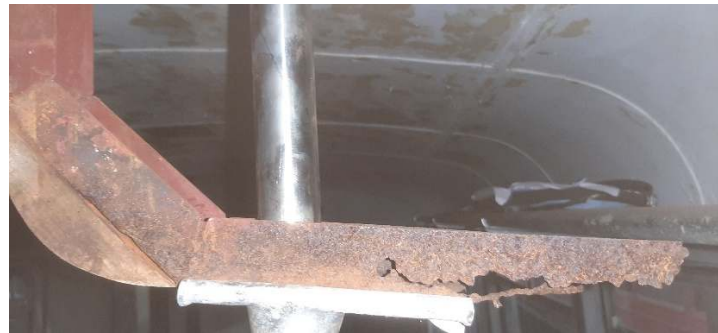
Above and below, before repair.

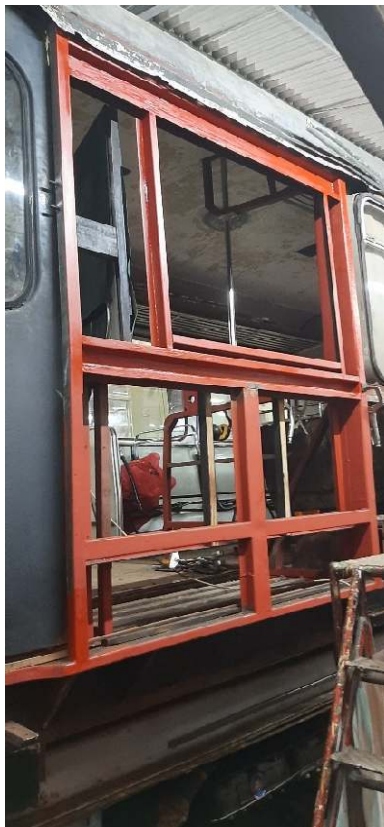
Frame repairs complete and primer painted.

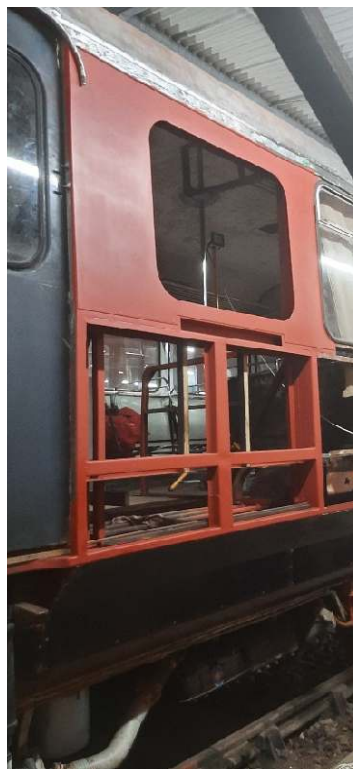
New outer skin panel fitted and painted in red oxide primer.

The Rainstrip and roof beading have been refitted.
