## **Restoration update March 2025**

After a very successful running season in 2024, the restoration of W79978 has continued through the winter months.

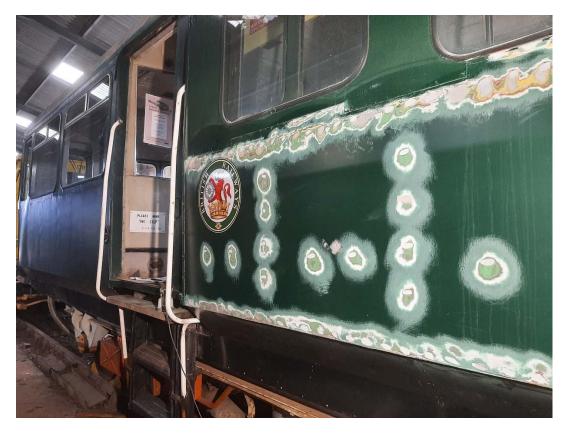
The outer panel refitted following last winter's body frame repairs has had all the rivet heads filled to create a smooth surface and has received several base coats of paint. The final gloss paint will be applied when the weather is more suitable and the mechanical works for this winter are completed, to reduce the risk of damaging the finished surface.

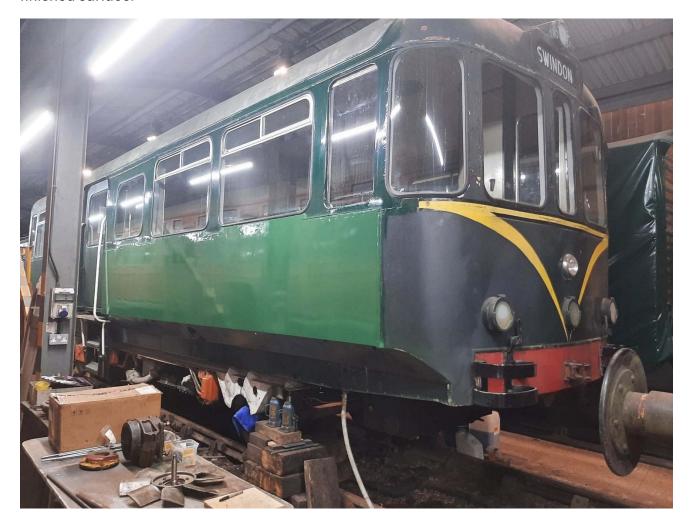
In addition to the panel repairs, here you can also see evidence of the other work being carried out, on the bench at the front are the radiator cooling fan and an axle bearing housing. The corner of the railbus nearest the camera has been raised on jacks to allow the axle bearing to be inspected, and on the other side are the containers which the engine coolant has been drained into.

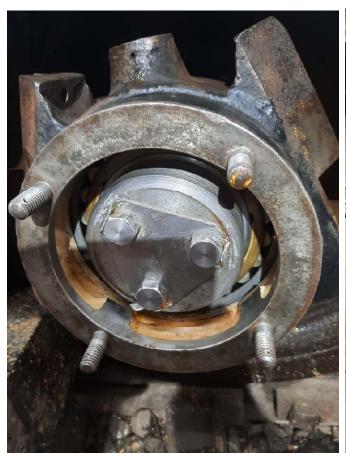
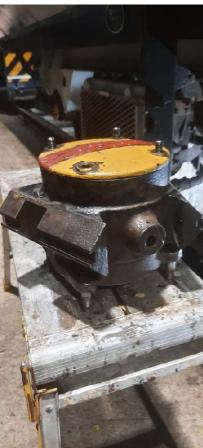
The axle bearings have all been inspected. This involves lifting the Railbus with hydraulic jacks and removing the suspension Chevron springs and axle bearing housing. The old grease is then removed, and the bearing carefully cleaned for a thorough visual inspection.

Three of the four bearings were found to be in good condition and have been reassembled. the fourth one unfortunately has corrosion damage and will be replaced.

Fortunately, the bearing is still obtainable, and a replacement has been purchased. Unsurprisingly a bearing of this size does not come cheap!

We now have the task of fitting the new bearing, hopefully this will be an easier task than removal of the defective one, which turned out to be quite a challenge.

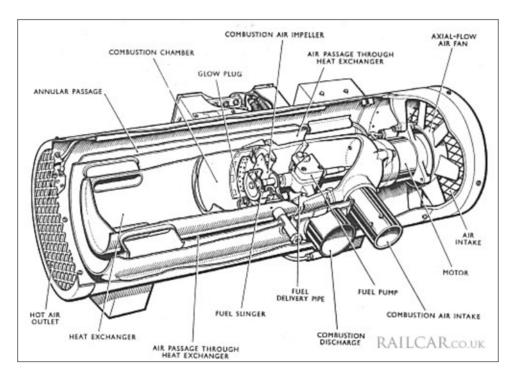
Interior heating for the Railbus is provided by a standard DMU type Smiths heater. This is mounted under the vehicle and operates by burning diesel fuel in the combustion chamber, air is passed over the outside of the heat exchanger by an electrically driven fan and transferred through ducts to the interior of the passenger compartment.

Image courtesy of Railcar.co.uk

The heater has been removed for overhaul as it was very noisy when operating.

The motor has now been rebuilt with new bearings, the fuel pump overhauled, and many other components cleaned, inspected and painted ready for reassembly. The heat exchanger requires some welding repairs to be completed before it can be refitted and the heater reassembled.

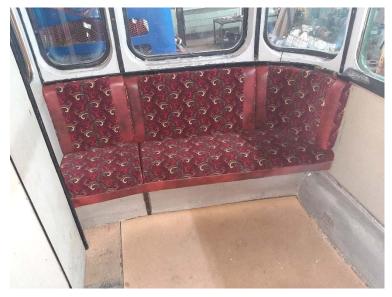
Retrimming is almost complete on the bay window seats at each end. Much of the original wooden framework for these had rotted away so there is a process of fit, remove and adjust then refit to get them just right.
