Restoration update July 2025

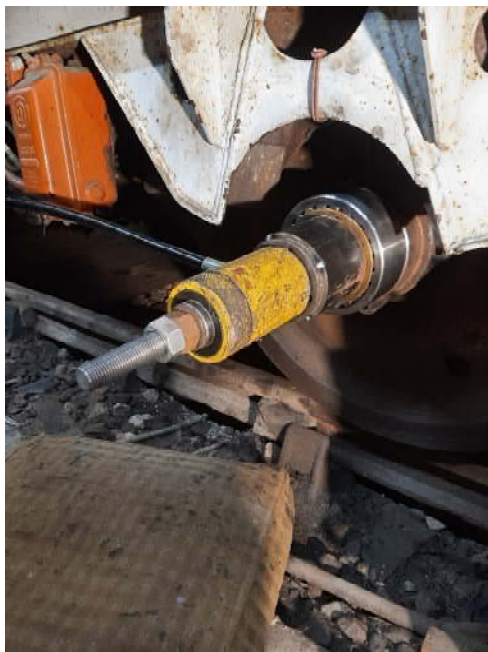
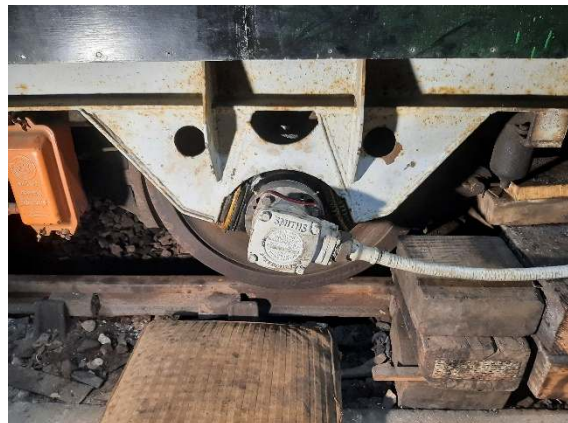
The defective axle bearing has now been replaced. This was achieved by heating the new one with an induction heater to 115°C and sliding it into place on the axle journal. An alignment tool was made and fitted to ensure the bearing went on square to the axle end, and it was then pressed into its final position with a hydraulic ram while it cooled. The end cap and bearing housing were then refitted and the bearing greased, finally the speedometer drive was refitted.

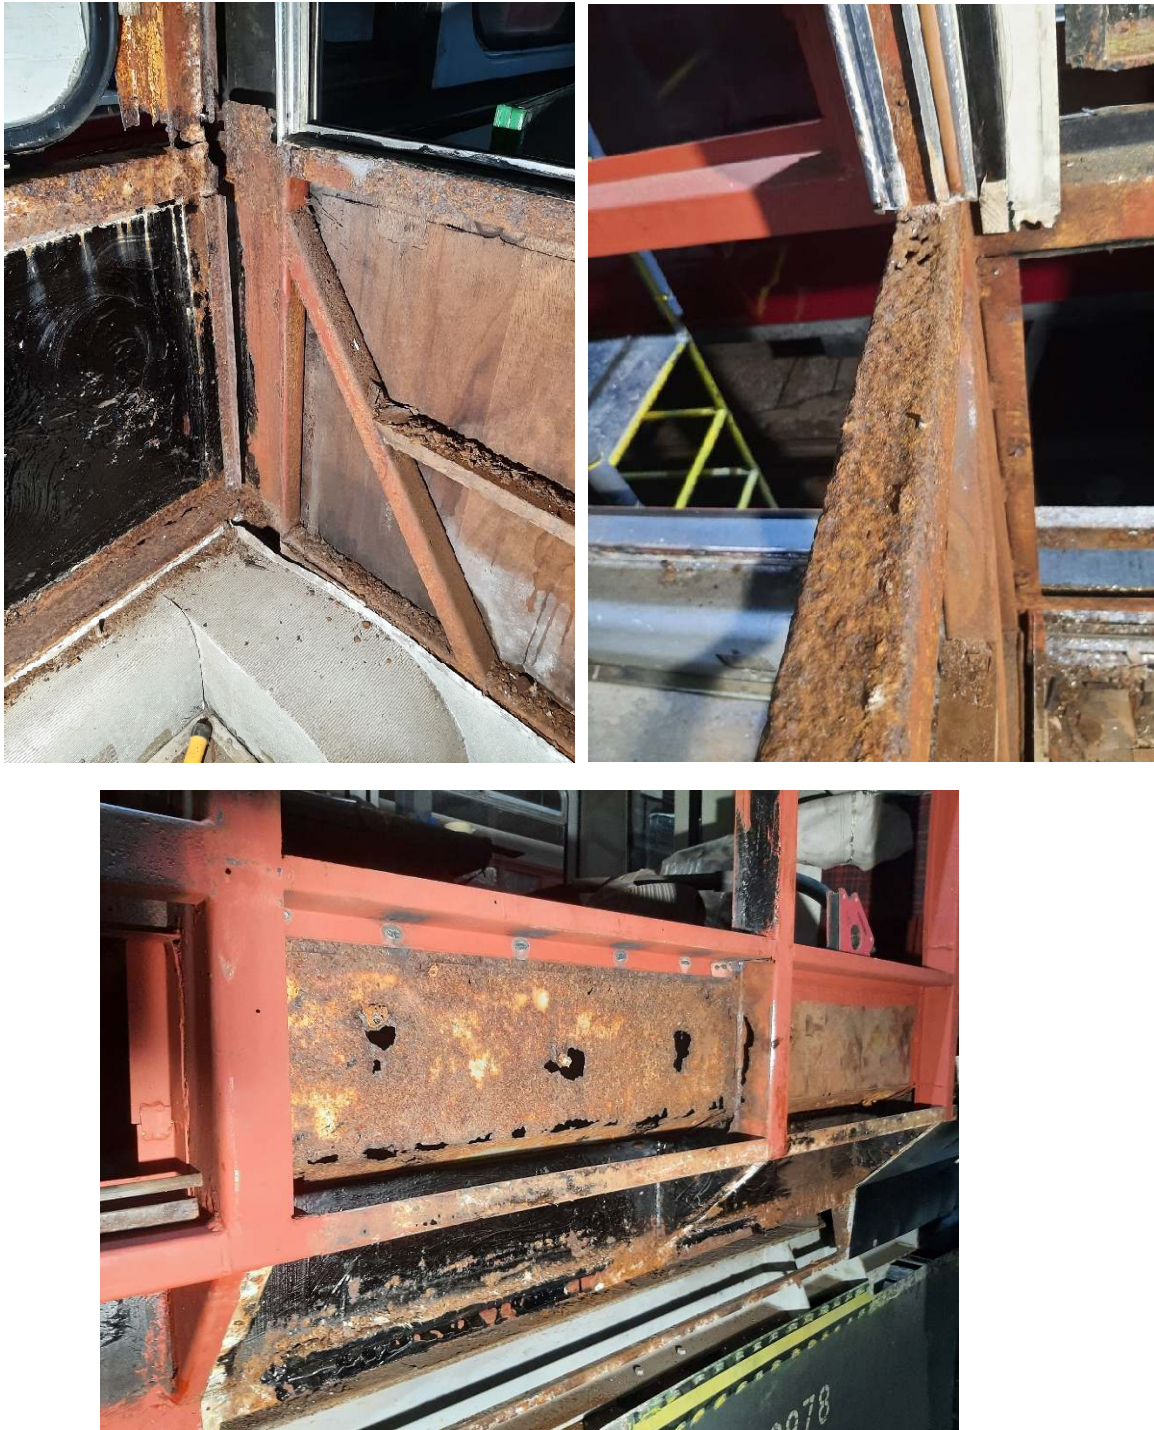
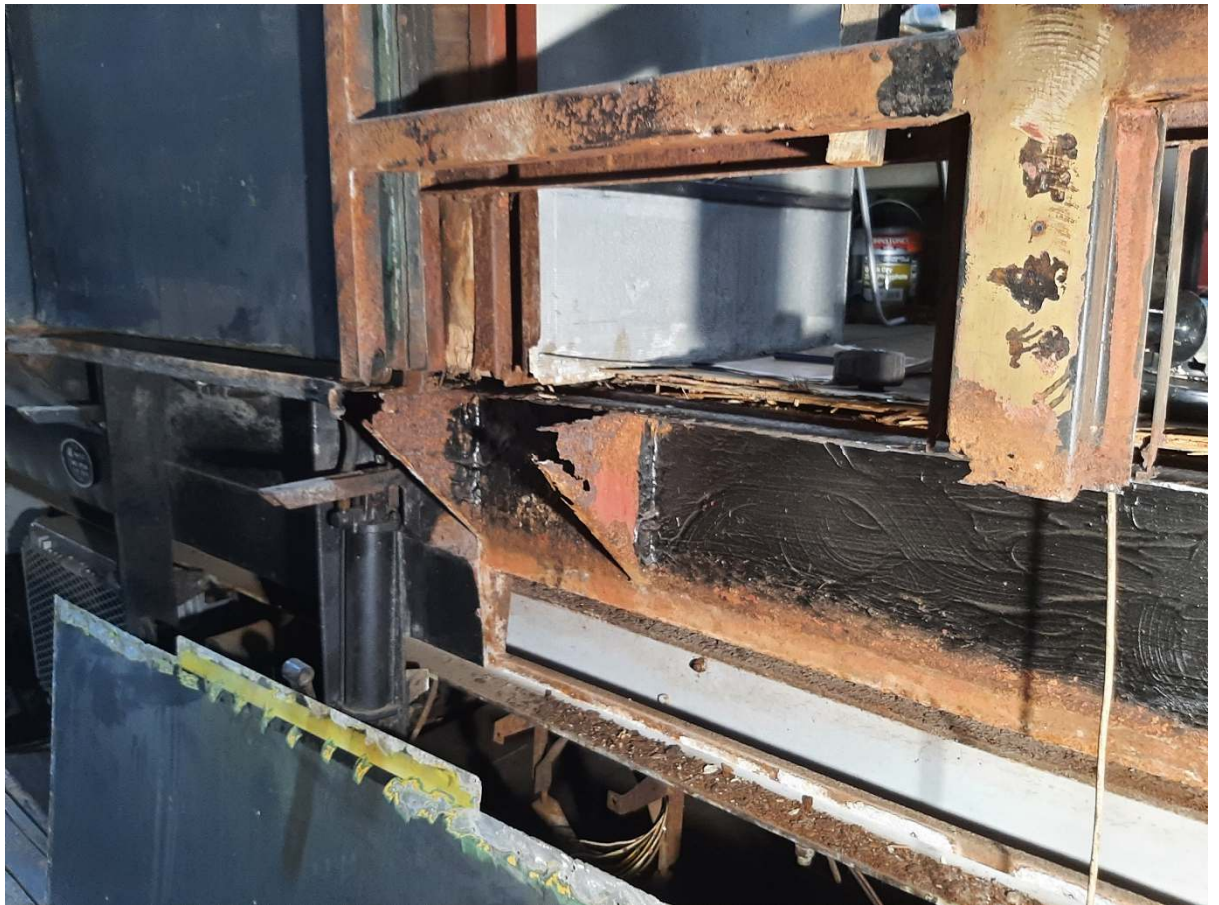
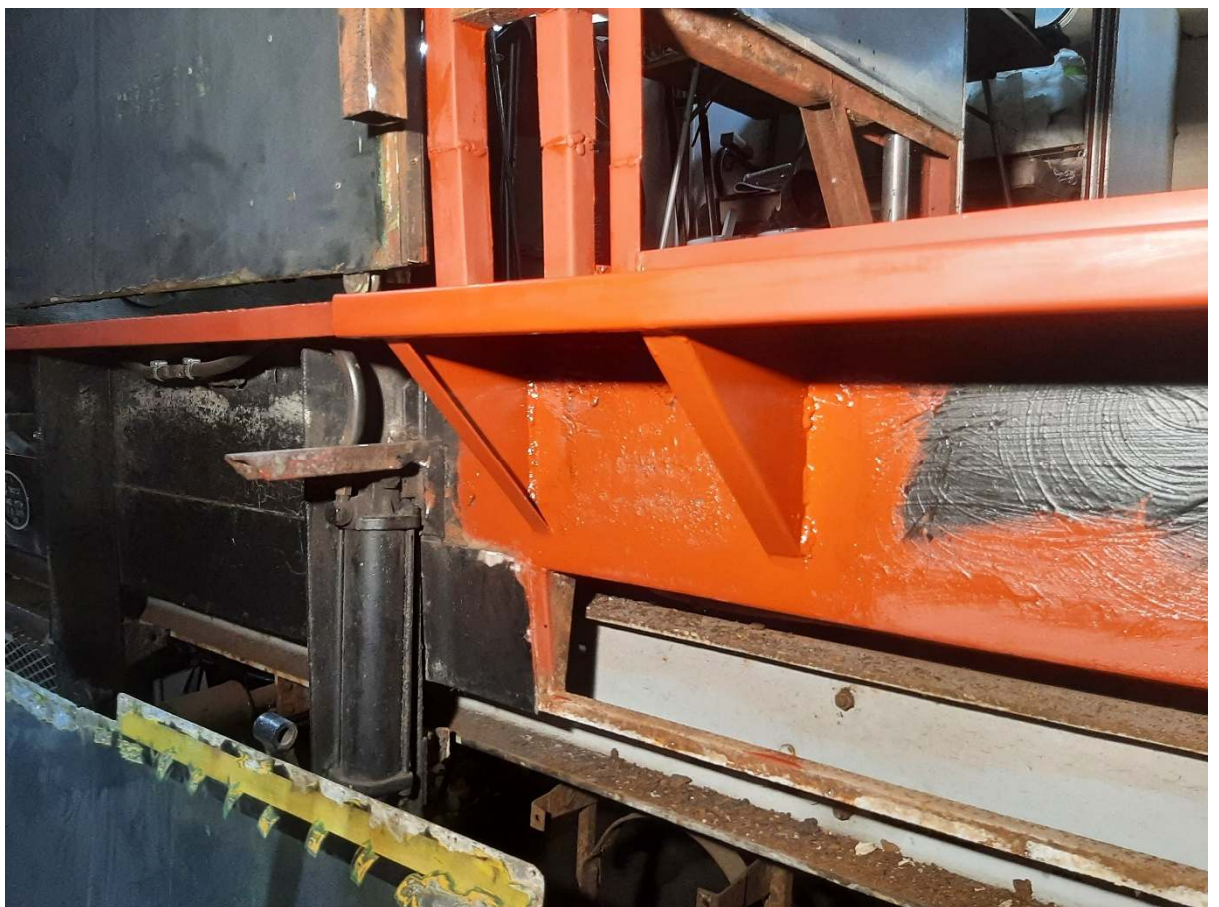
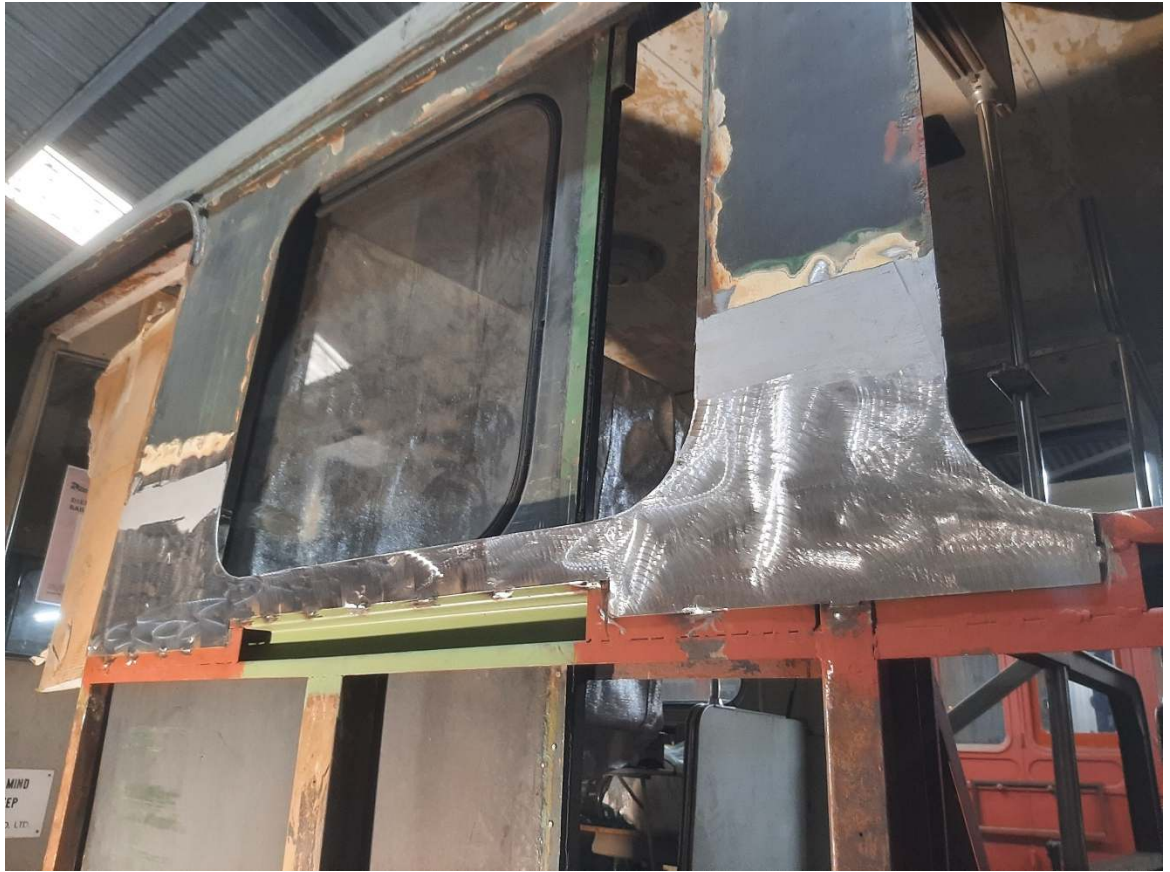
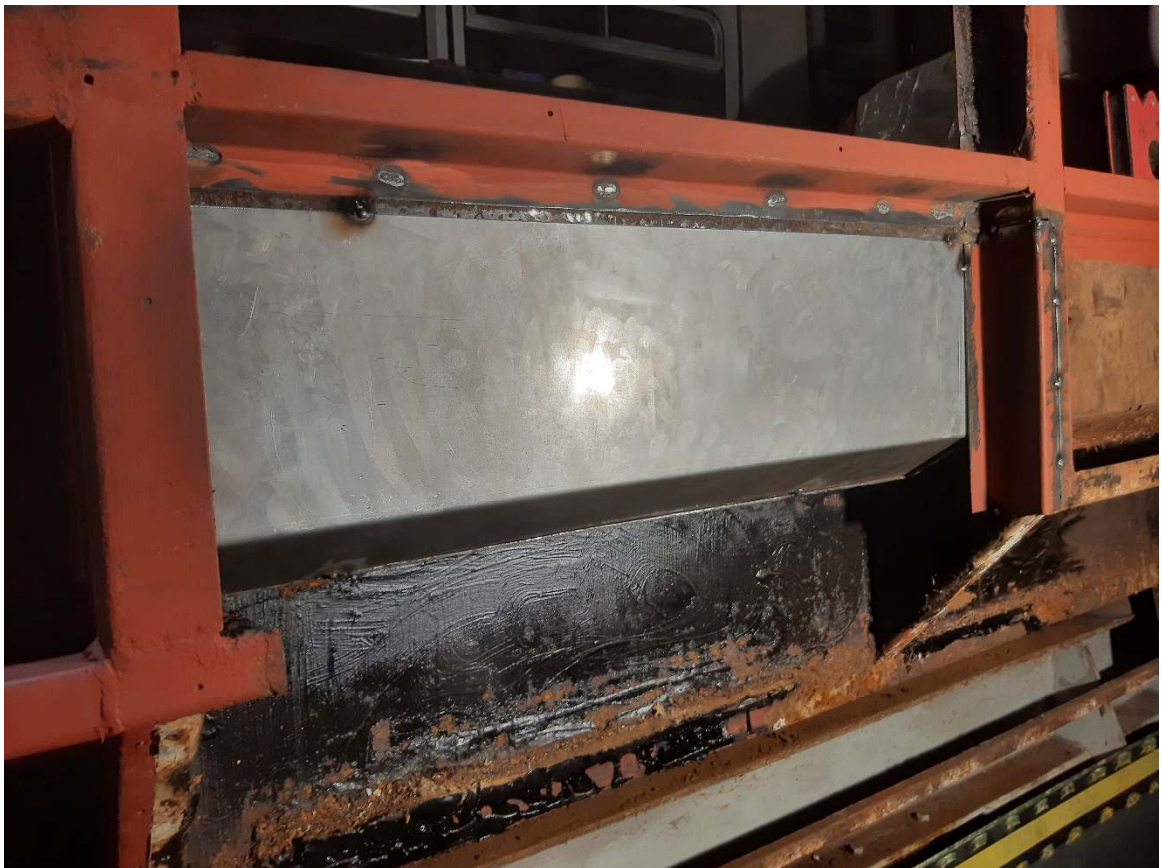
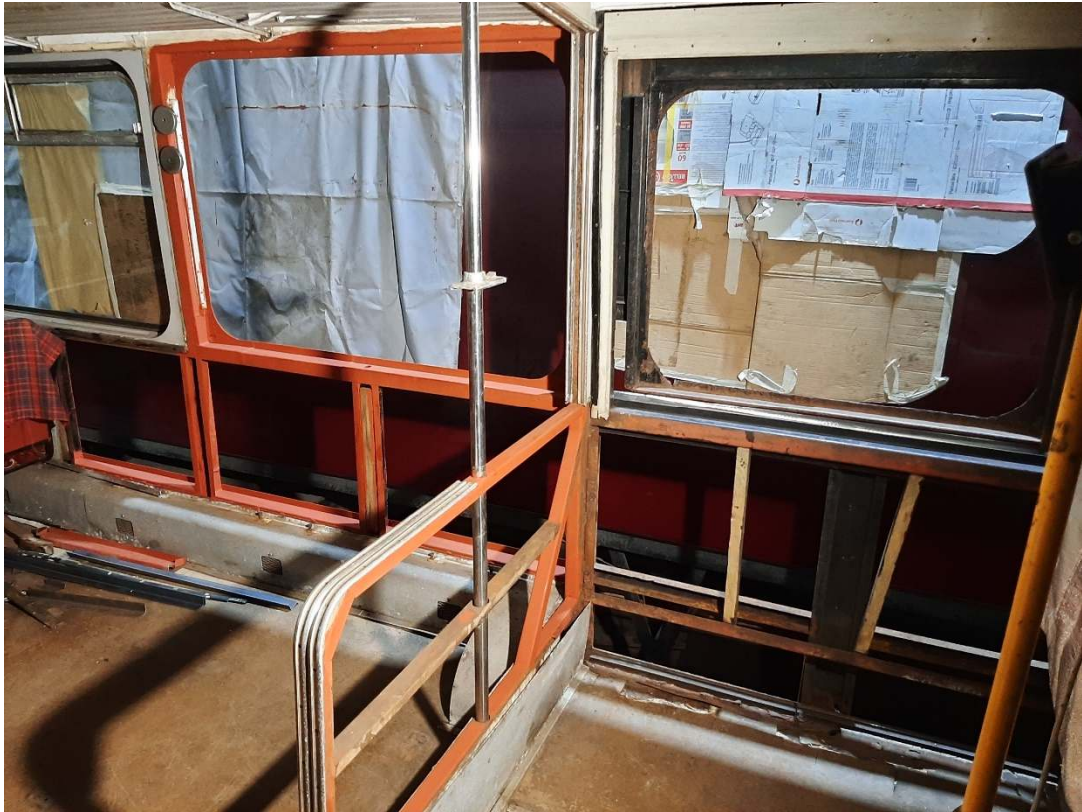
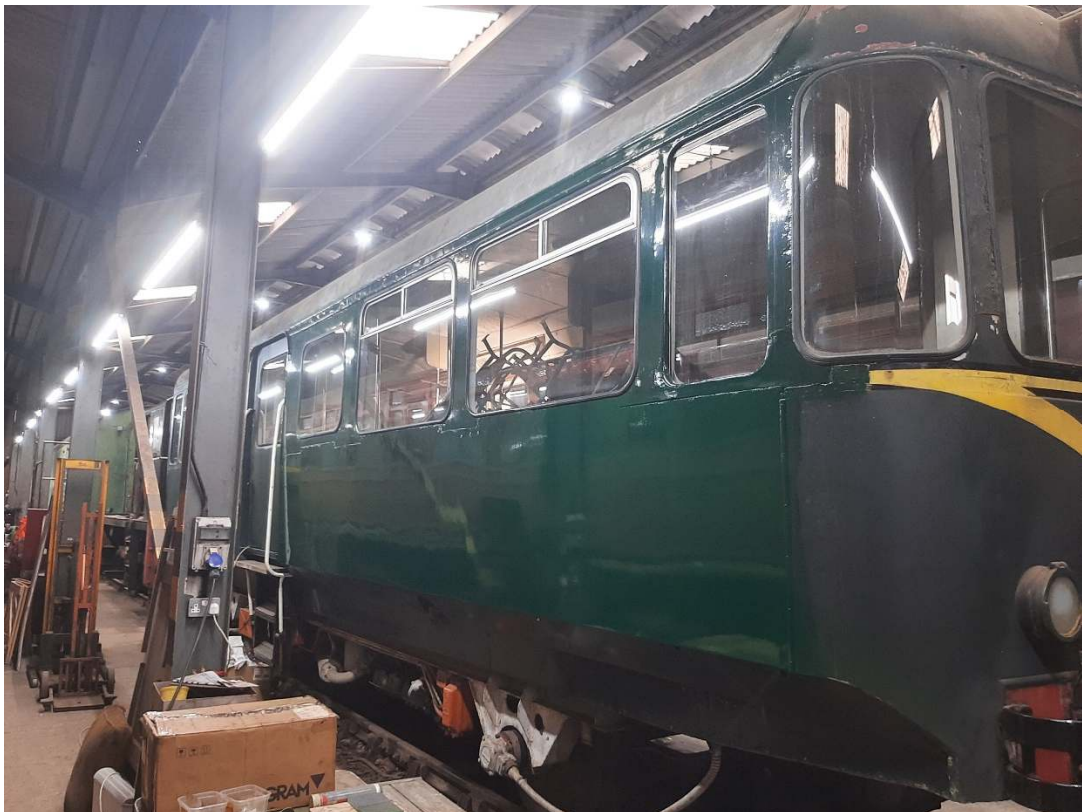
Attention has now been turned to resuming the body frame repairs. This time working on the Left hand rear bodyside. The outer panel, four rows of seats, two windows and the interior panelling has had to be removed, along with a section of floor to gain access to the area being worked on. This is the section diagonally opposite that which has been repaired over the last two winters.
