AC Railbus W79978 – restoration update October 2022

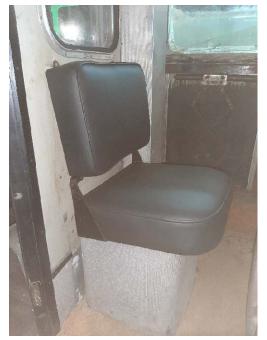
The droplight windows in each corner were all stuck in the open position, this has allowed rainwater into the vehicle and contributed to the damage to the floor and body frame. The scissors and spring mechanism has been repaired and now the droplights work correctly for the first time in many years! To access the mechanism the interior Formica panels and external valence panels had to be removed. As expected, this revealed further corrosion.
